National Transportation Safety Board

Pipeline Accident Brief

Accident No.:	DCA-99-MP-004
Type of System:	Natural gas service line
Type of Accident:	Rupture, explosion, and fire
Location:	Bridgeport, Alabama
Date and Time:	January 22, 1999, 10:02 a.m. CST
Owner/Operator:	Utilities Board of the City of Bridgeport
Property Damage and Losses:	\$1.4 million
Fatalities:	3
Injuries:	6
Material Released:	Natural gas
Pressure:	35 psig
Type of Failure:	Excavation damage
Component Affected:	¾-inch steel gas service line

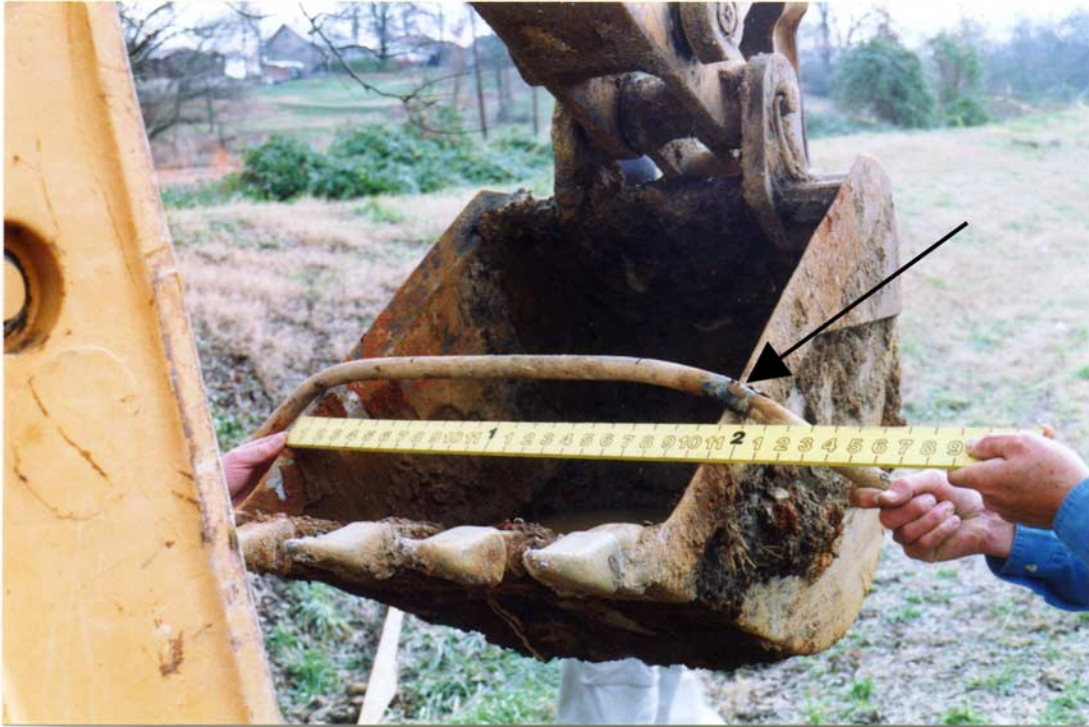
On January 22, 1999, while digging a trench behind a building at 406 Alabama Avenue, a backhoe operator damaged a ¾-inch steel natural gas service line and a 1-inch water service line. This resulted in two leaks in the natural gas service line, which was operated at 35 psig. One leak occurred where the backhoe bucket had contacted and pulled the natural gas service line. (See figure 1.) The other was a physical separation of the gas service line at an underground joint near the meter, which was close to the building. Gas migrated into the building at 406 Alabama Avenue, where it ignited about 10:02 a.m. An explosion followed, destroying three buildings: 404, 406, and 408 Alabama Avenue (see figure 2). Other buildings within a two-block area of the explosion sustained significant damage. Three fatalities, five serious injuries,¹ and one minor injury resulted from this accident.

Figure 1. Damaged section of the gas service line to 406 Alabama Avenue. (Arrow shows leak location. Note how the bowed area corresponds with the width of a backhoe bucket.)

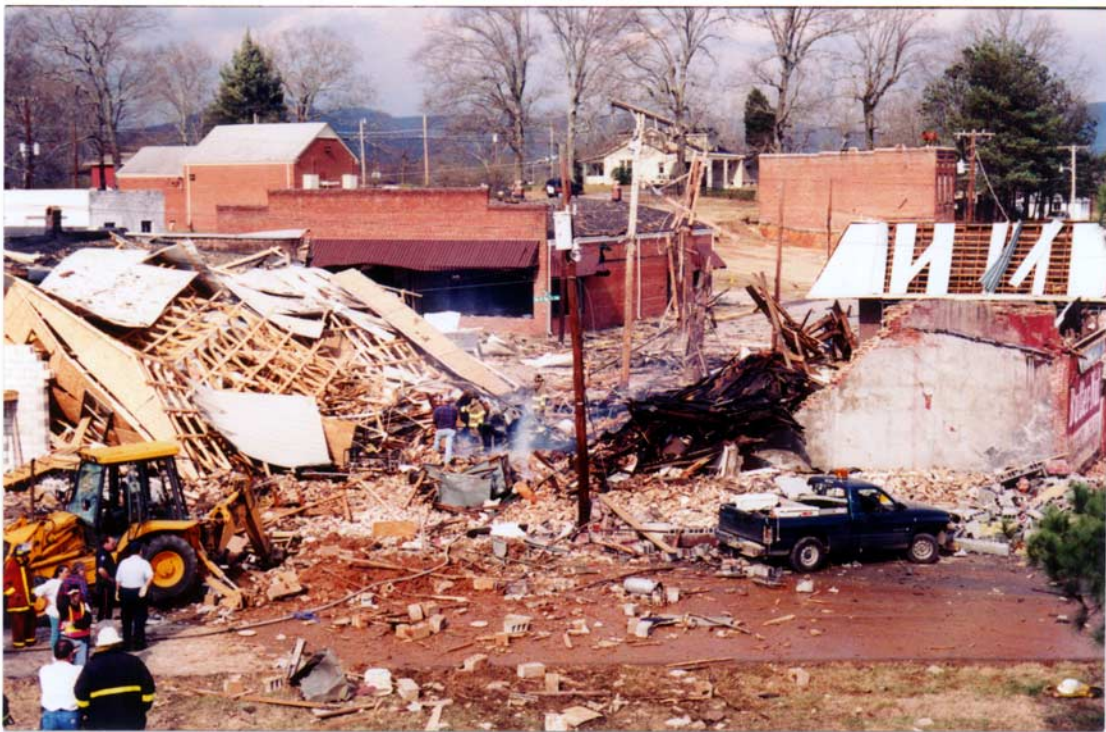
Figure 2. Damage to 404, 406, and 408 Alabama Avenue

Shortly after the Utilities Board backhoe operator started digging, the building at 406 Alabama Avenue exploded. The owner of 408 Alabama Avenue, the R&B backhoe operator, and a Utilities Board employee received fatal injuries. Five other people, including a bystander, received serious injuries, and one person received a minor injury.

The Alabama State Fire Marshals Office determined that the likely source of ignition for the accumulated natural gas was a gas-fired heater at 406 Alabama Avenue, which had an active pilot light at the time of explosion.⁵ The Superintendent of the Utilities Board estimated that within 5 to 10 minutes after the explosion he had closed two valves on the 4-inch natural gas main feeding the natural gas to the broken service line.

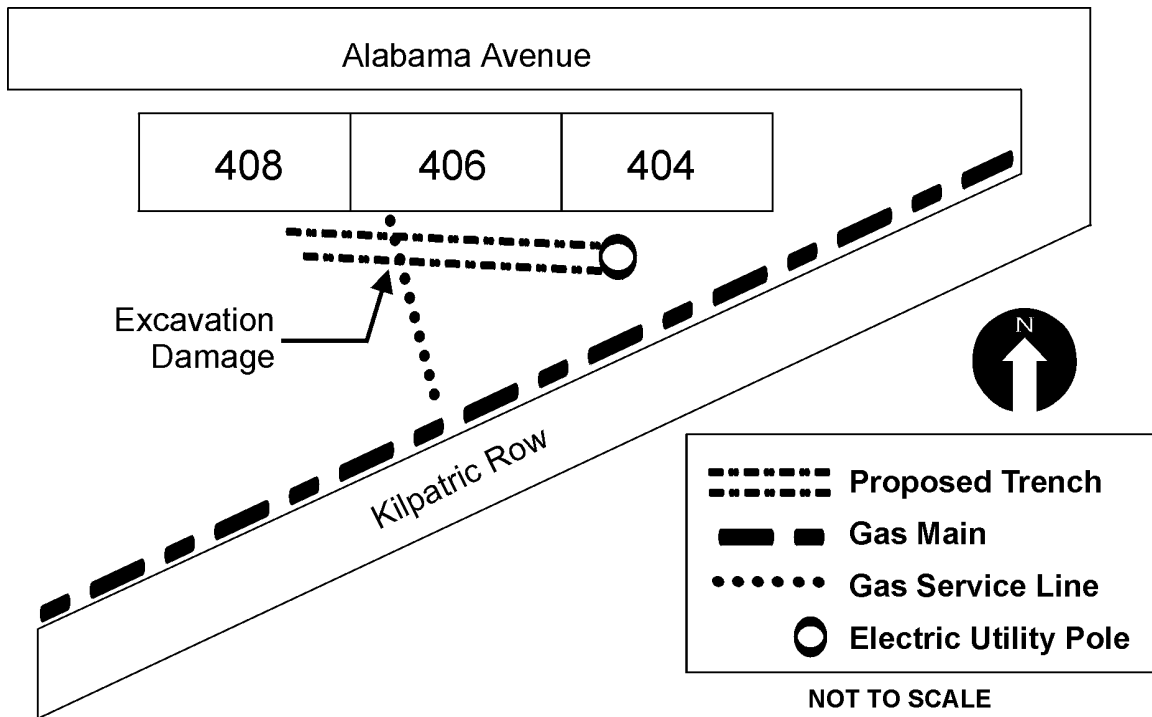
Figure 3. Schematic of accident area

The owner of R&B Construction (R&B) told investigators that the owner of 408 Alabama Avenue had hired R&B to dig a trench from an electric pole behind 404 Alabama Avenue to his building for an underground electric service cable. (See figure 3.) The owner of R&B told investigators that he had not planned beforehand to dig the trench to 408 Alabama Avenue on the morning of the accident and that he did not call the Alabama Line Location Center, Inc.² However, when a part-time employee, who had operated a backhoe for R&B in the past, arrived at the R&B office the morning of January 22 looking for work, the owner of R&B decided to have the employee dig the trench that day.
