PIPELINE ACCIDENT REPORT

**ARIZONA PUBLIC SERVICE COMPANY
NATURAL GAS EXPLOSION AND FIRE
PHOENIX, ARIZONA
SEPTEMBER 25, 1984**

NTSB/PAR-85/01

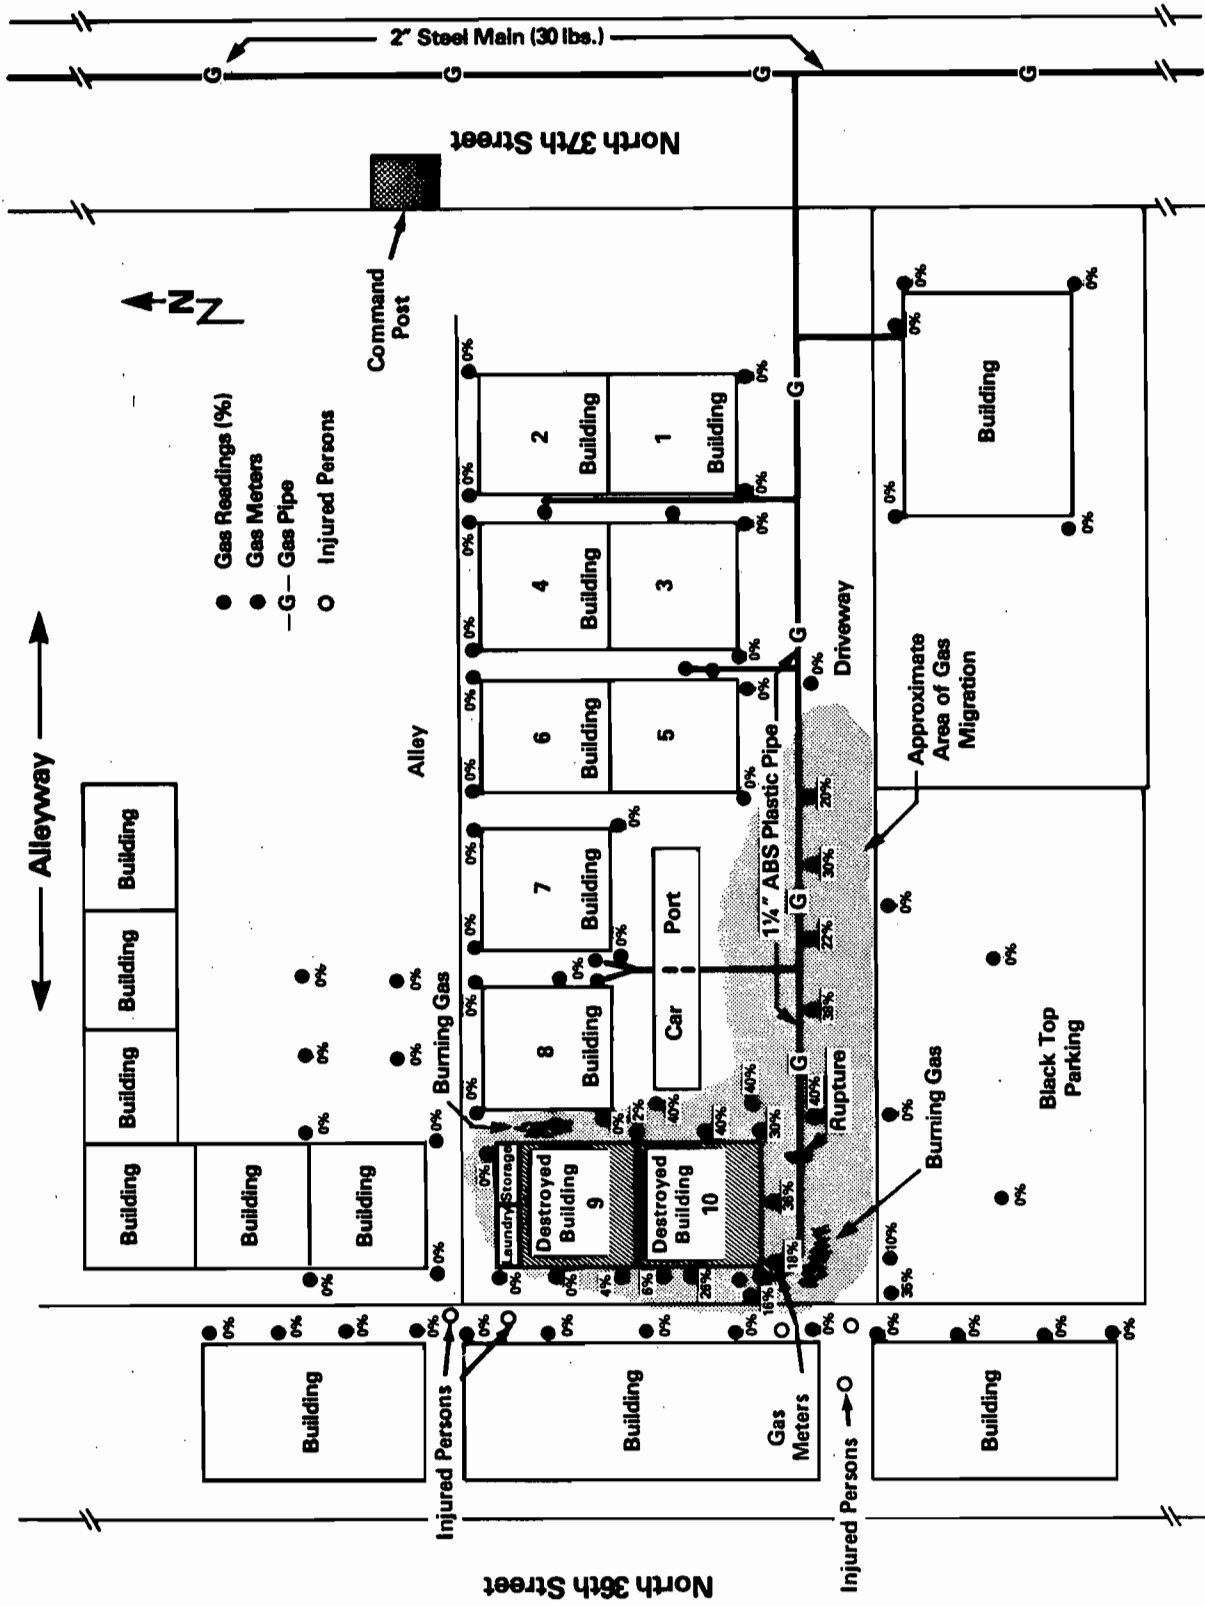
Figure 1.--Plan view of the accident site showing locations and results of gas company's bar hole tests.

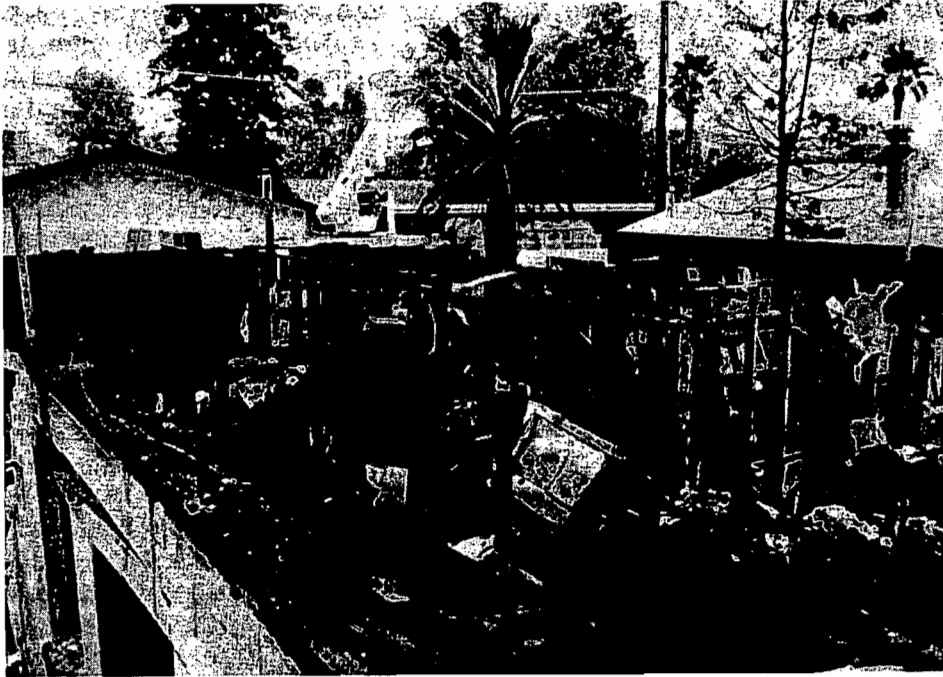
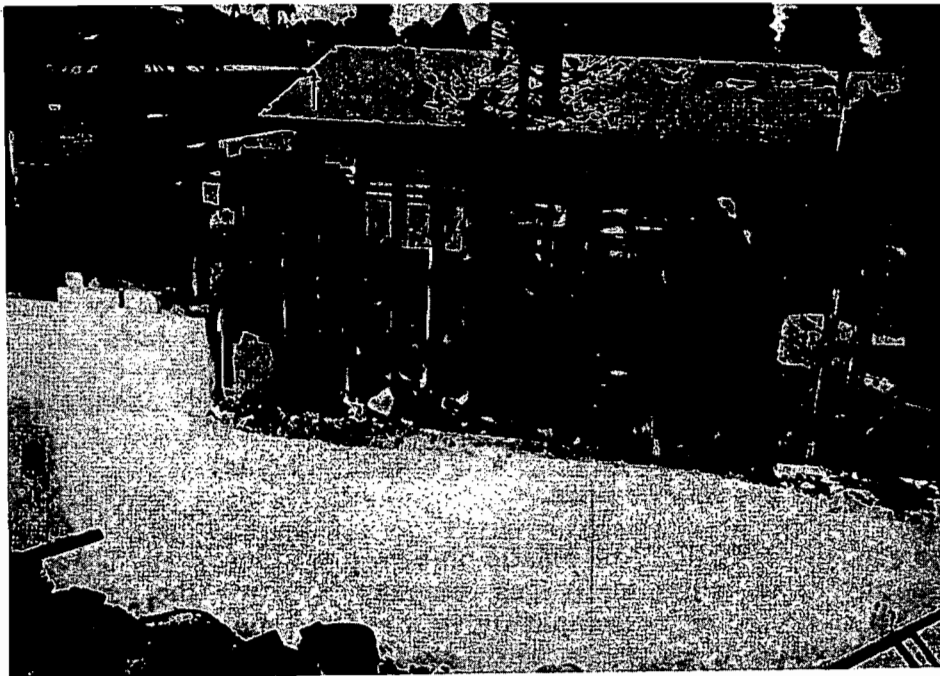
Apartment Nos. 9 and 10 were destroyed (see figure 3), and apartment No. 8 sustained some structural damage and broken windows. One automobile was destroyed, two automobiles were damaged heavily, and three other automobiles and a motorcycle also were damaged.

**Figure 3.--Apartment No. 9 (top)
and apartment No. 10 (bottom) destroyed by fire.**
