PIPELINE ACCIDENT REPORT

**TEXAS EASTERN GAS PIPELINE COMPANY
RUPTURES AND FIRES
AT BEAUMONT, KENTUCKY
ON APRIL 27, 1985 AND
LANCASTER, KENTUCKY
ON FEBRUARY 21, 1986**

NTSB/PAR-87/01

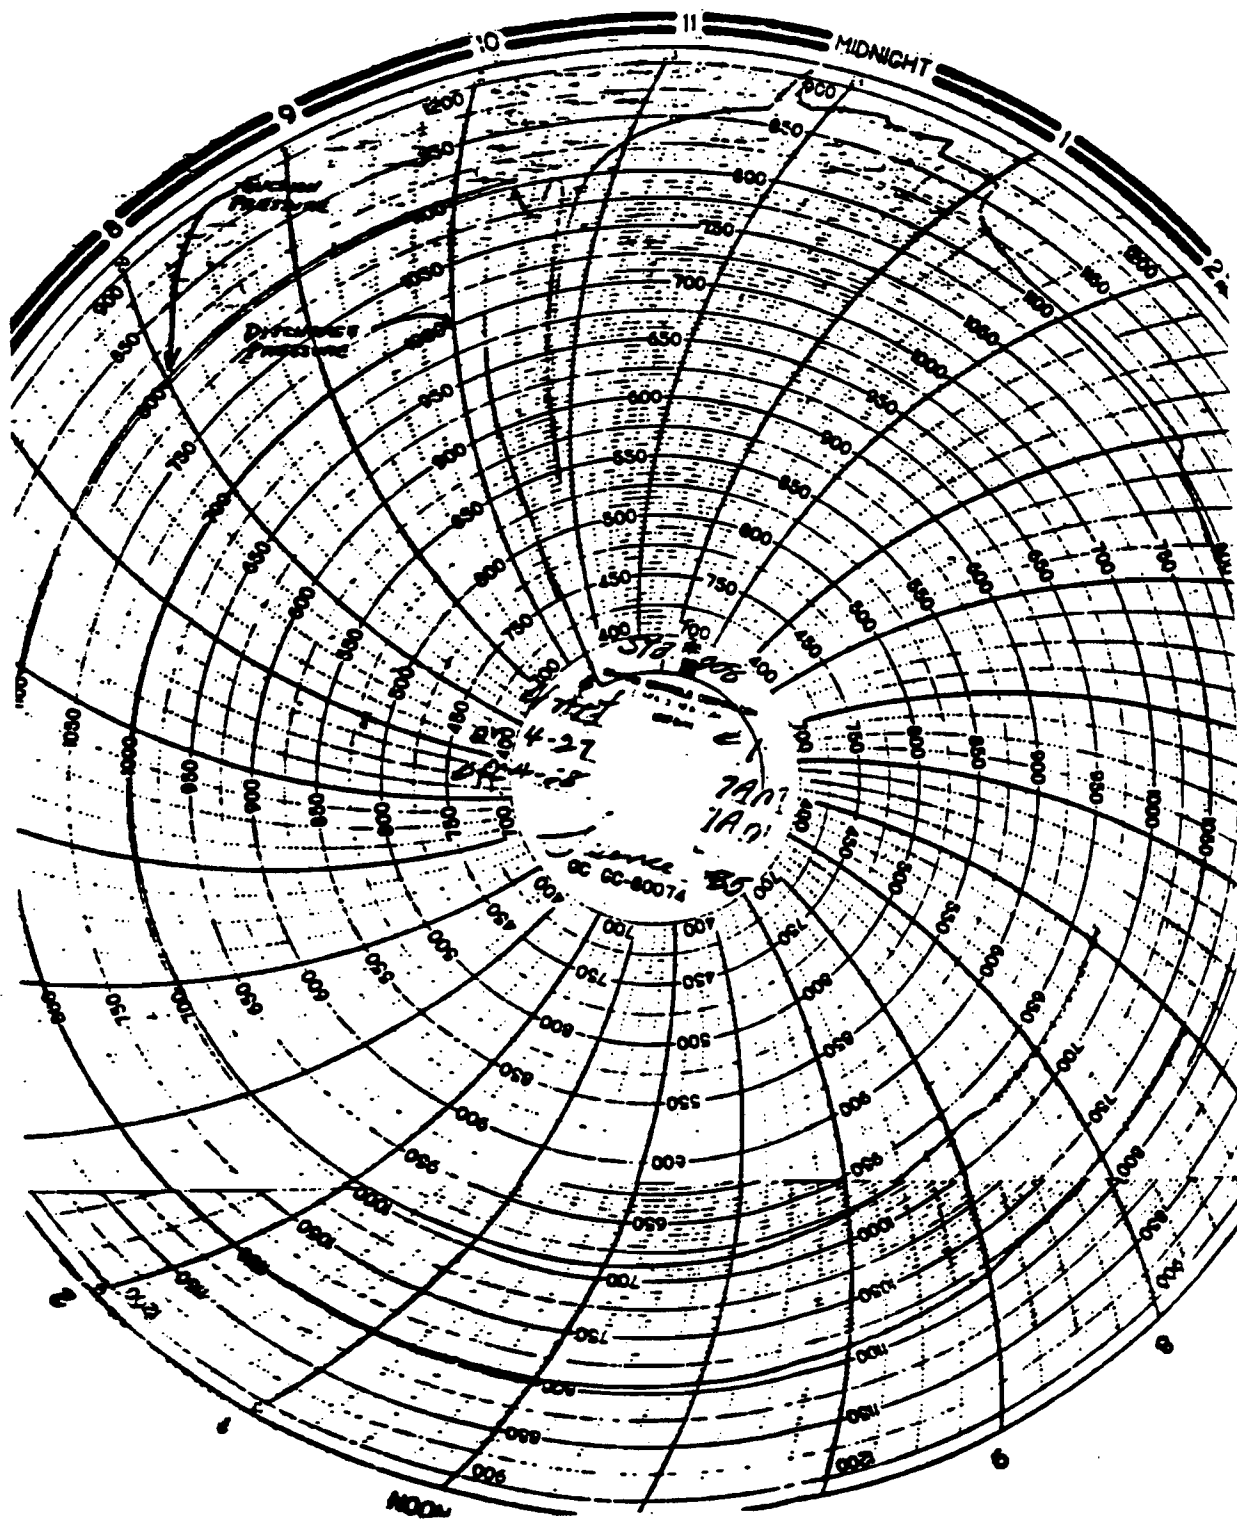
Figure 1.— Tompkinsville pressure recording chart.

telephoned his supervisor and advised him of the drop in pressure (see figure 1). The supervisor directed the station operator to shut down the No. 1 compressor which was compressing gas into the No. 10 pipeline and told the station operator that he would come to the compressor station and close the valve on the No. 10 pipeline in the compressor yard. The station operator ran toward the compressor to shut it down, and on the way he saw a large orange glow in the sky north of the compressor station indicating to him that the No. 10 pipeline had ruptured and that the escaping gas had ignited. The station operator shut down the No. 1 compressor at 9:15 p.m.

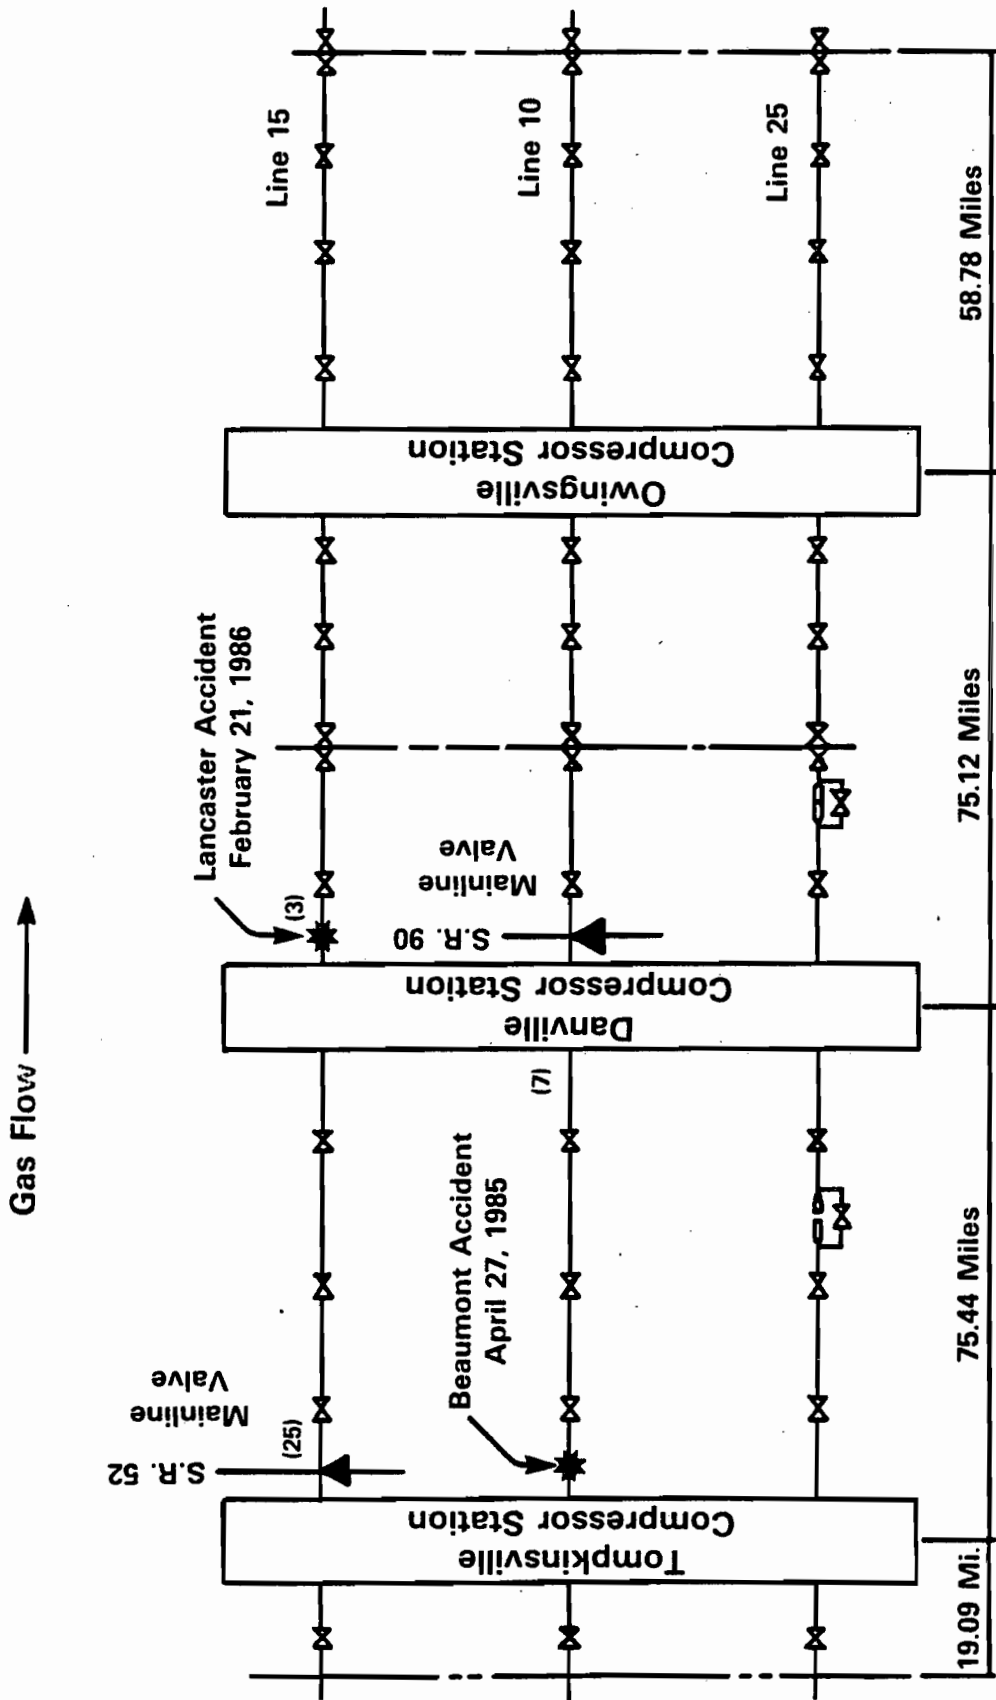
Figure 2.—Schematic diagram of the pipeline system.

The in-line inspection program began in May 1985 on line No. 10 and was completed in November 1985. Gas company personnel worked with the in-line instrument inspection company personnel to verify each instrument run and analyze the graphs. At the end of each instrument run, the instrument was removed from the pipeline and the information on its magnetic tape was used to make a temporary working graph. The magnetic tape was then mailed to the instrument company's office for refining, editing, and enlarging. In about 4 to 6 weeks, the completed, permanent graph was sent to the gas company's measurement and corrosion department in Houston, Texas. The in-line inspection instrument identified several locations where previously undetected corrosion was present. Thirty-five sections of pipe at various locations between Beaumont and Owingsville were replaced and additional pipe replacements were scheduled. (See figure 2.)

By February 1986, based on its inspection data, the gas company had excavated and replaced 35 sections of pipe between its Tompkinsville and Owingsville compressor stations because of corrosion damage. Twenty-five replacements were made on the No. 10 pipeline on the discharge (downstream) side of the Tompkinsville compressor station, seven replacements were made on the No. 15 pipeline on the suction side (upstream) of the Danville compressor station, and three replacements were made on the No. 10 pipeline on the discharge side of the Danville compressor station. (See figure 2.) No pipe had been replaced on the No. 15 pipeline on the discharge side of the Danville compressor station at that time. After all postaccident in-line inspections had been completed and analyzed, the gas company removed more than 400 sections of corroded pipe from its system in Kentucky alone. Although the majority of the 400 sections replaced were not critically corroded, the gas company considered the corrosion to be serious enough for the pipe sections to be replaced. The gas company had been unaware of the corroded areas before using the in-line inspection equipment even though the Federal regulation for inspection for corrosion was being met.

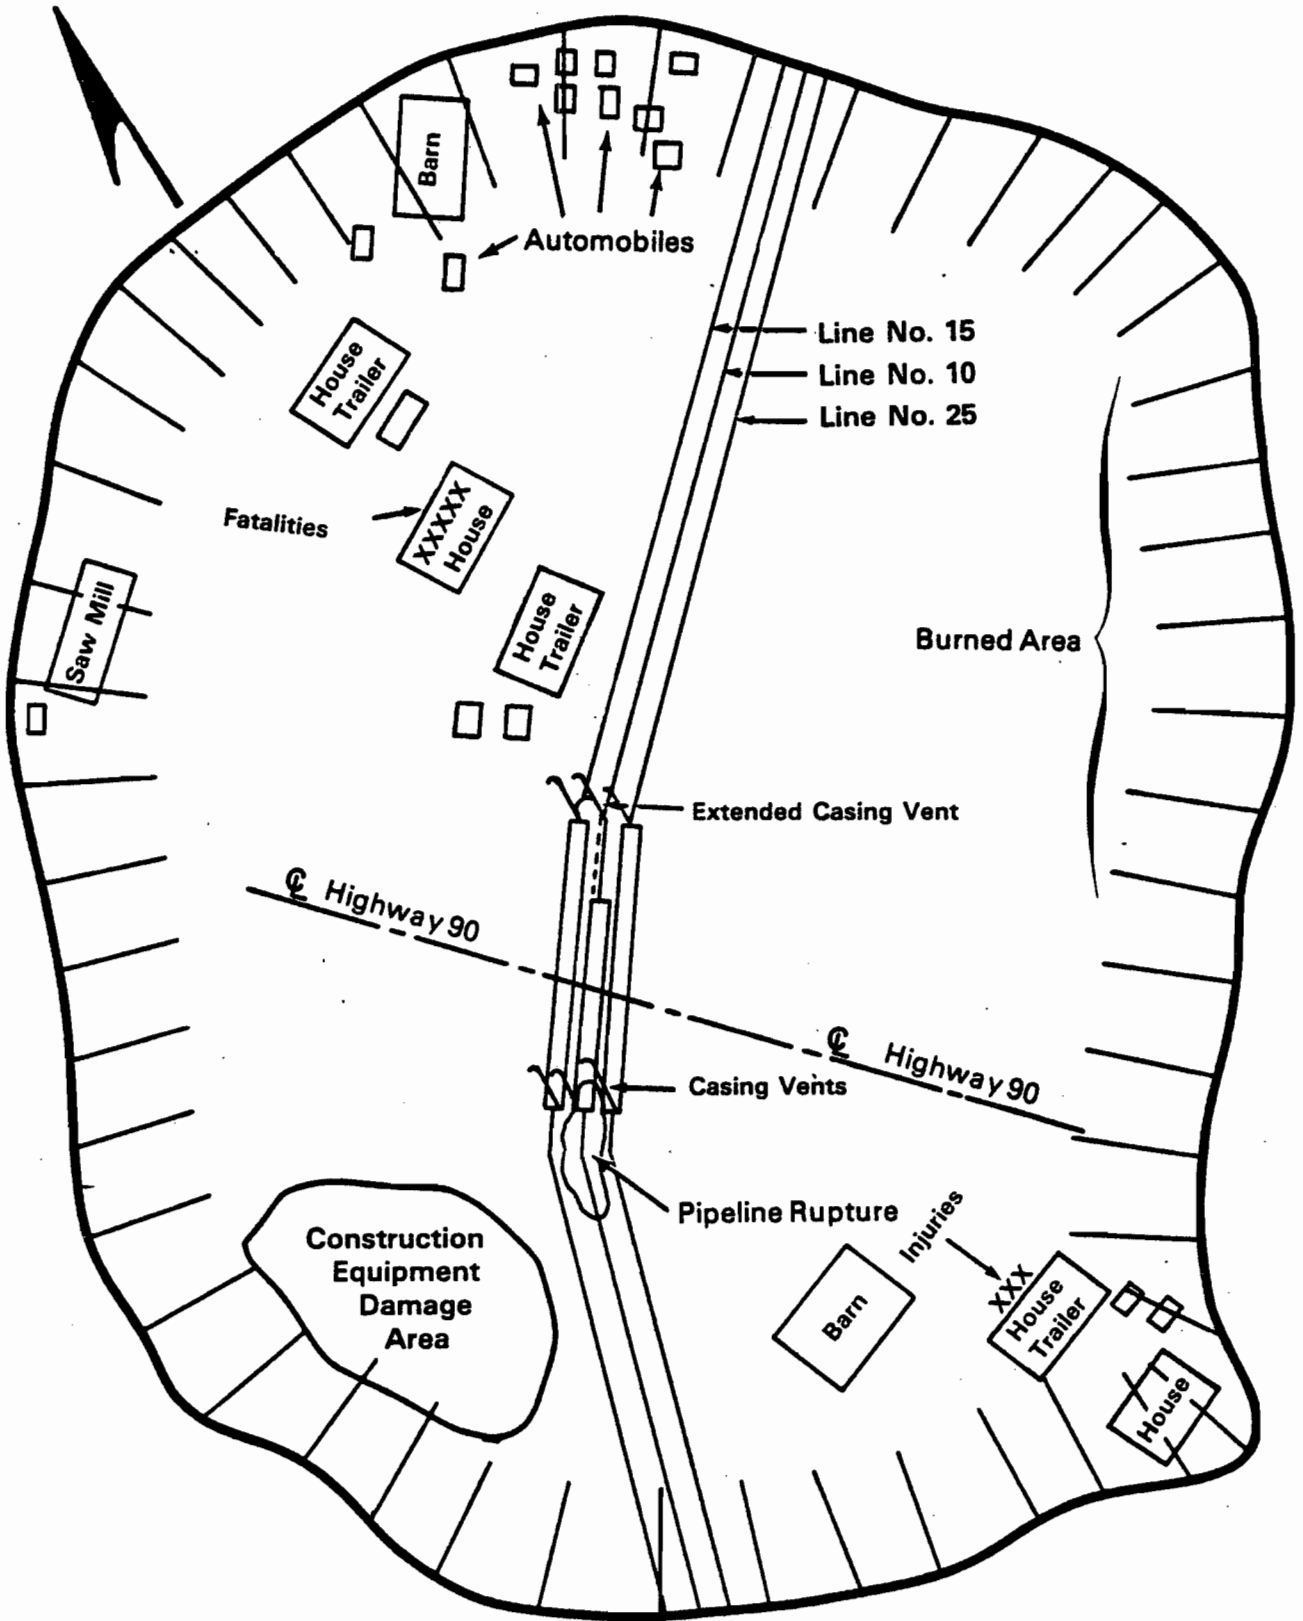
Figure 3.—Diagram of the accident site at Kentucky State highway 90.

Five persons in a house 318 feet north of the rupture were killed and three other persons were burned while fleeing from a house trailer 320 feet south of the rupture. The gas-fueled fire destroyed two houses, three house trailers, a sawmill, two barns, a school bus, numerous parked and abandoned automobiles, nine pieces of road construction equipment, and other items. (See figure 3.)

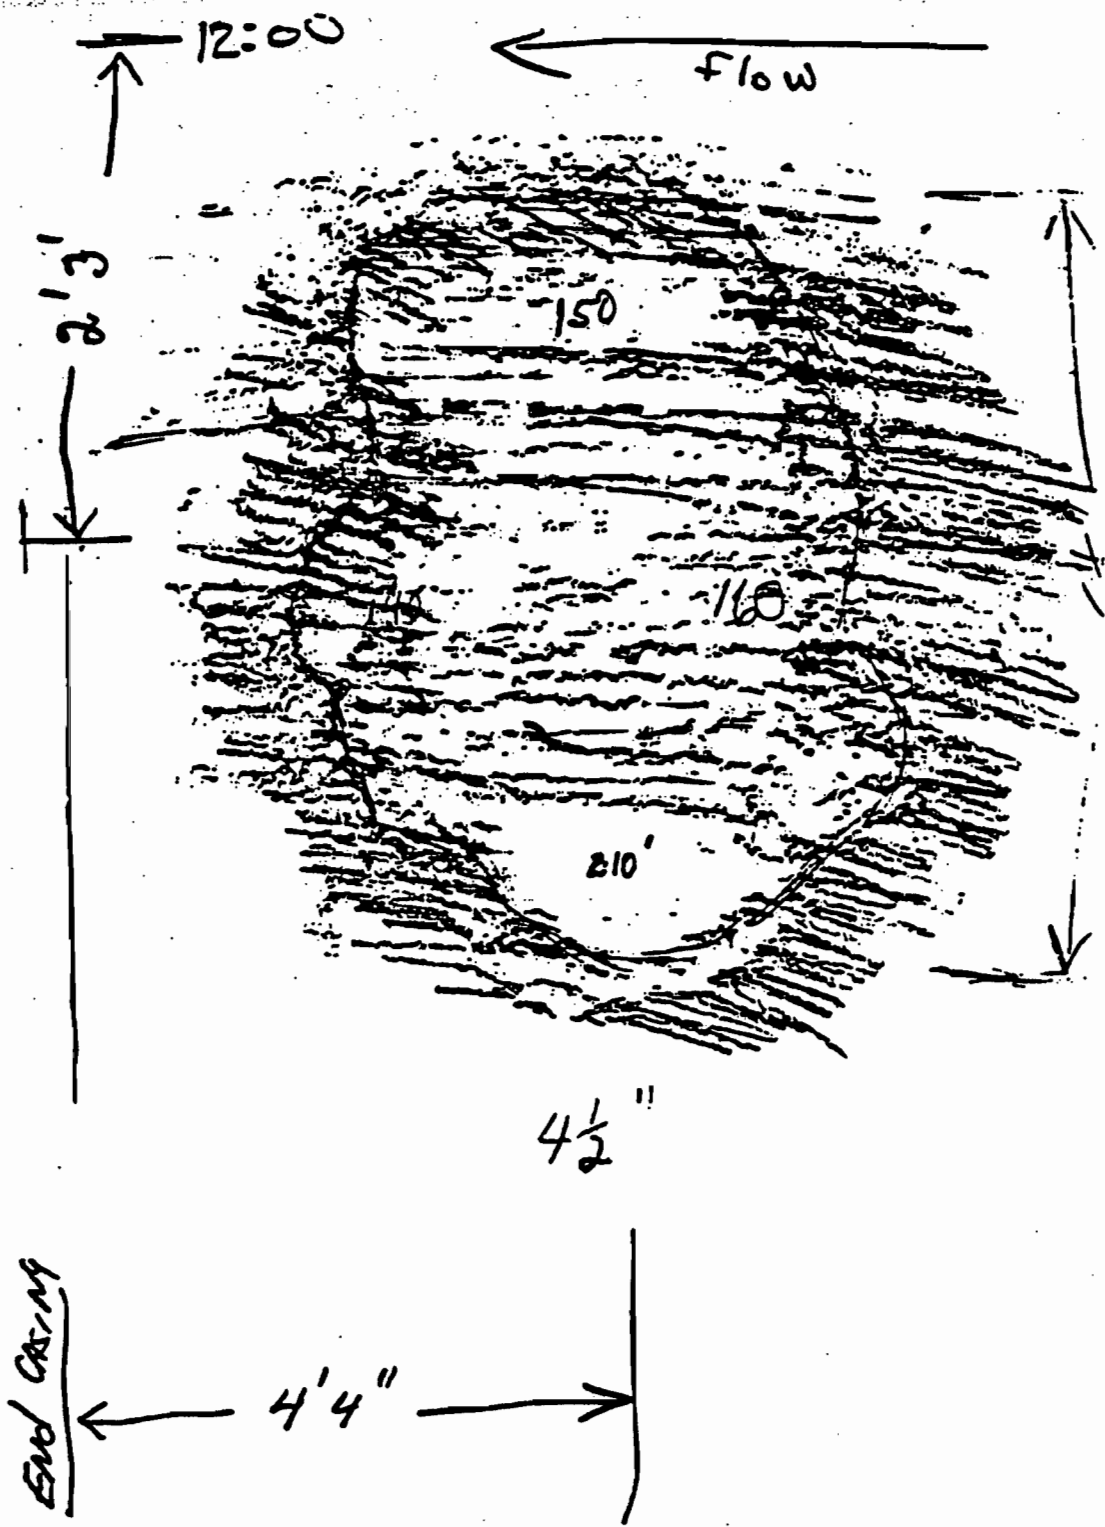
Figure 4b.—Tracing made of area and depth of corrosion at the south end of the casing under State highway 52.

The pipe could not be easily inspected completely because it was resting on a rock ledge. This prevented the gas company's personnel from determining whether the corrosion extended further along the underside of the pipe and it prevented their measuring the depths of pits close to the rock. The gas company personnel did make a notation on the "instrument verification" report that said "unable to gauge center, probably deeper than 190 mils." However, some information required to be entered on the report form used for the "instrument verification" was not provided, the report was not signed, and the company's personnel did not describe the condition of the pipe or the degree of corrosion. The corroded areas that were measured for depth and traced for area and configuration ranged from a 260 mil pit (55.4 percent of the 0.469 inch pipe wall thickness) at the girth weld joining the 0.469 inch wall thickness pipe to the 0.375 inch wall thickness pipe, to a 190 mil pit (50.7 percent of the 0.375 inch wall thickness pipe). In addition, a band of general corrosion on the bottom of the pipe about 5 feet in circumferential length and 1 foot in longitudinal length was located between the 260 mil and 190 mil pits.

At that time, the gas company had no written criteria or company guidelines for categorizing various degrees of pipeline corrosion, i.e., light, moderate, severe, or critical. Based on his knowledge and experience, each corrosion technician was expected to make his own judgment as to the severity of the corrosion. The representative from the corrosion control department from Houston and the local measurement and corrosion technician had different opinions about the effect of the corrosion. The representative from Houston considered what he saw to be "severe but not critical" corrosion; however, he believed the corroded pipe would eventually have to be replaced. The local measurement and corrosion technician, when questioned about the corroded pipe during the Safety Board's investigation stated, "I would say in the medium, possibly medium heavy, however [sic] terms you want to use, not all that critical, nothing to cause any great alarm."

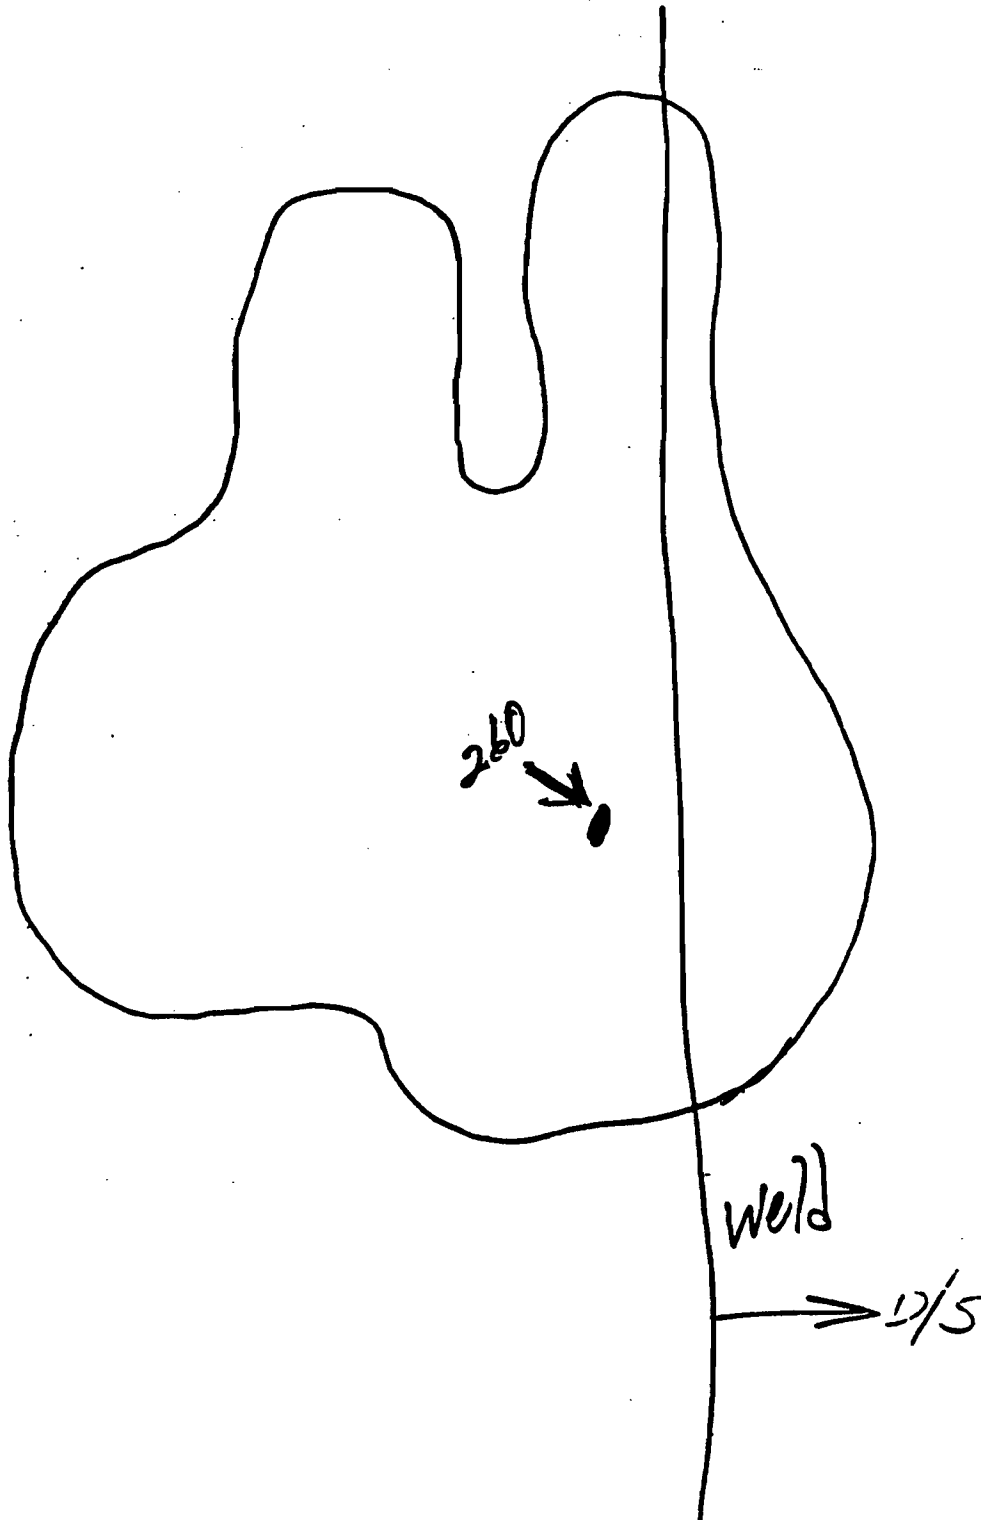
Figure 4c.—Drawing of area and deepest penetration of corrosion in No. 15 pipeline south of State highway 52.

The origin of the fracture was determined to be in an area of corrosion on the outer surface of a 0.375-inch wall thickness pipe section. The origin was determined to be at the bottom of the pipe approximately 14 feet south of the girth weld joining the 0.375-wall thickness pipe to a section of 0.469-inch wall thickness pipe (transition weld). The location of the corroded area roughly corresponds to the edge of the large rock ledge in the bottom of the pipeline trench as noted in the September 14, 1985, "instrument verification" report. Thirteen areas of corrosion were found on the outer surface of the first pipe length south of the transition girth weld. The failure initiation point was approximately 14 inches south (upstream) of the last pit that the corrosion technicians were able to measure (the 190 mil depth pit).

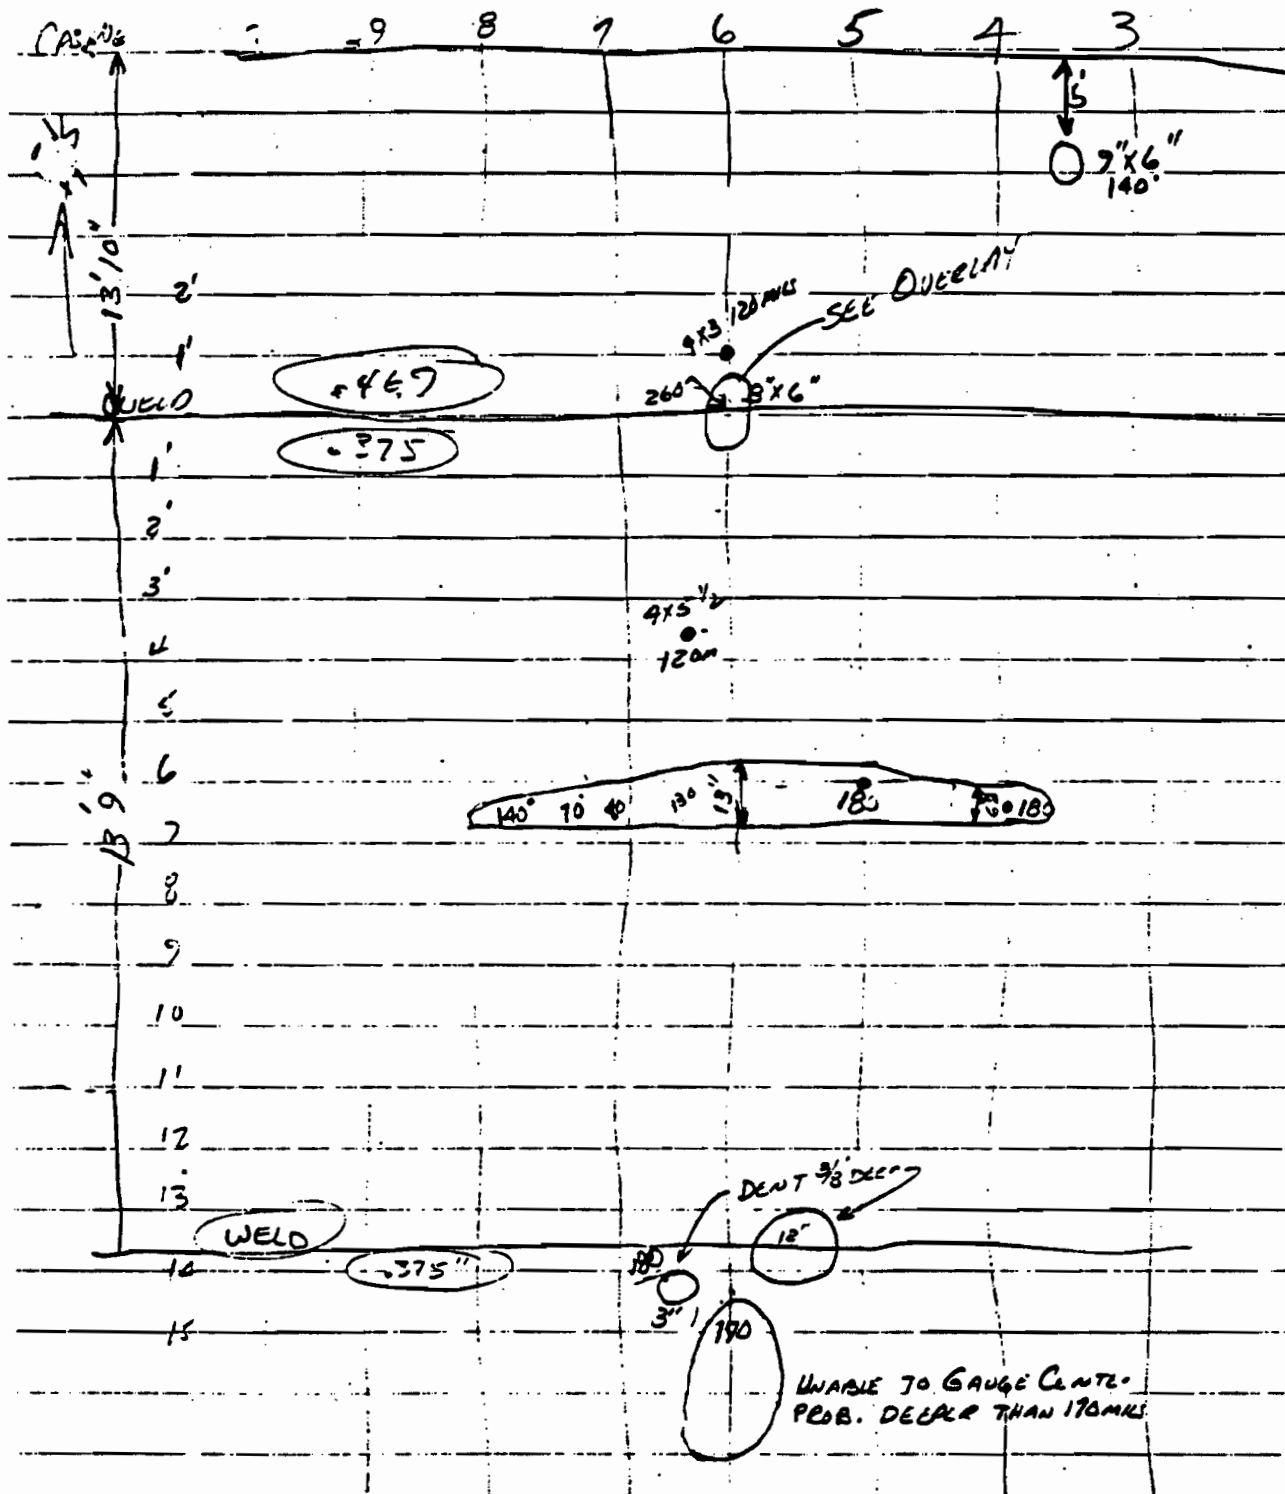
Figure 4d.—Drawing of overall corrosion areas and depths of penetration on No. 15 pipeline south of State highway 52.

The failure initiated at an area of corrosion that was 26 inches in longitudinal extent and 10 inches in circumferential extent. Within this region, more than half of the wall thickness had been lost for a distance of 9 inches along the fracture path. This corroded region was located

almost on the bottom of the pipeline at a point where the pipeline may have been resting on a solid rock ledge. Calculations using the A.G.A. (American Gas Association) surface flaw equation revealed that the region of metal loss would have been expected to fail at a pressure level of 962 psig. Thus, it is reasonable to believe that the failure was the result of the observed corrosion.

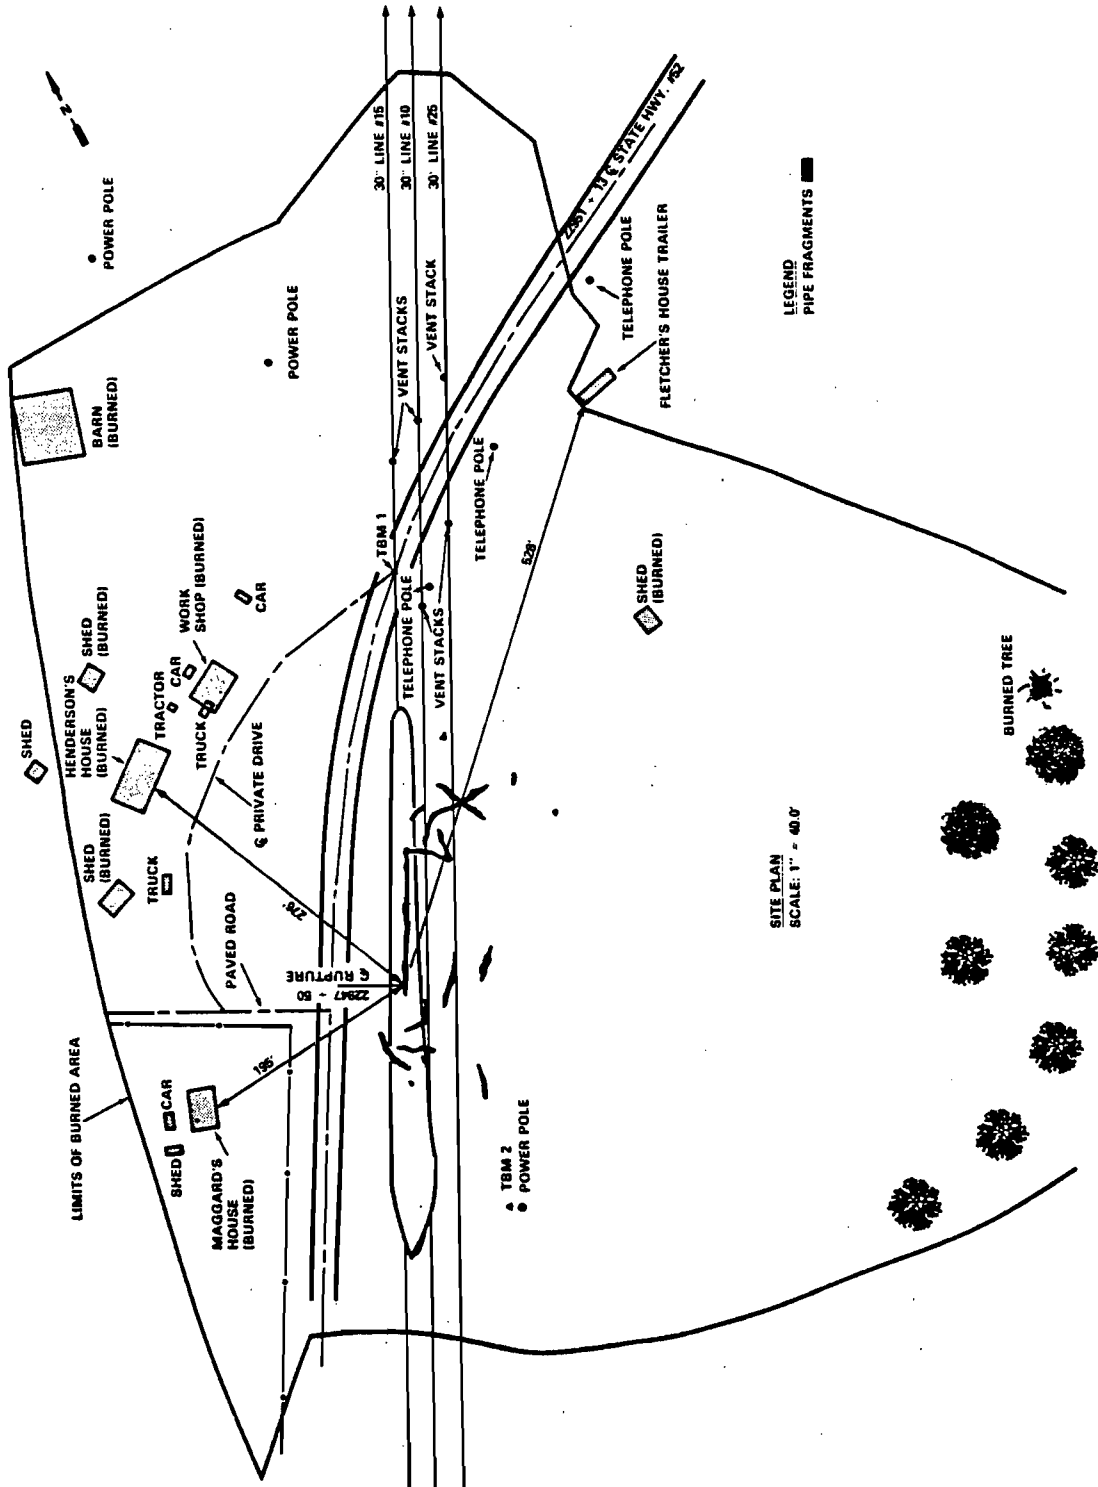
Figure 5.—Diagram of the accident site at Kentucky State highway 52.

On February 21, 1986, at its Danville compressor station near Lancaster, the gas company was compressing natural gas to 1,000 psig in three parallel pipelines extending northward from the station. This compressor station contained 10 gas engine-driven compressors and 2 electric motor-driven compressors. The compressor station had been operating steadily at this pressure and had experienced no pressure upsets or rapid pressure changes. At 2:05 a.m., the station operator noticed a sudden drop in the discharge pressure on the No. 15 pipeline. As the pressure in the No. 15 pipeline dropped, the engine-driven compressors automatically speeded up in an attempt to maintain the 1,000 psig set pressure. In so doing all 10 engine-driven compressors exceeded the engine overspeed limitation and were shut down automatically by the speed control. In compliance with gas company emergency procedures, the station operator immediately telephoned the gas company's dispatchers in Houston, informed them of the problem, and then closed the station valve on the No. 15 pipeline. (See appendix B.) Natural gas under 987 psig (75.9 percent of SMYS) ruptured the gas company's 30-inch-diameter No. 15 pipeline about 30 feet south of the casing pipe that crossed under State highway 52, about 7 miles from Lancaster. The force of the escaping gas tore 480 feet of the pipeline out of the ground and excavated an area 500 feet long, 30 feet wide, and 6 feet deep.

The escaping natural gas ignited almost immediately and incinerated an area extending more than 900 feet north and south and 1,000 feet east and west. Three persons were burned as they escaped from their frame house located 280 feet west of the rupture and five other persons suffered minor injuries; two persons were burned as they ran from a trailer house located 525 feet north of the rupture and three persons were burned as they ran from a brick house located 200 feet southwest of the rupture. The two houses were destroyed by fire and the house trailer was damaged beyond repair due to the heat of the fire and by debris propelled by the force of the escaping gas. Two barns, several small buildings, and four automobiles were destroyed and about 15 acres of pasture and woodland were burned. Seventy-seven persons were initially evacuated from the area, but were allowed to return to their homes later the following day. (See figure 5.)
