National Transportation Safety Board

Pipeline Accident Brief

Pipeline Accident Number:	DCA-95-MP-001
Type of System:	Gas distribution
Accident Type:	Explosion and Fire
Location:	Waterloo, Iowa
Date and Time:	October 17, 1994; 10:07 a.m. local
Owner/Operator:	Midwest Gas Company ¹
Fatalities/Injuries:	Six fatalities and seven non-fatal injuries
Damage:	\$250,000
Material Released:	Natural Gas
Pipeline Pressure:	25 pounds per square inch, gauge (psig)
Component Affected:	1/2-inch plastic pipe at steel tapping tee mechanical compression connection to steel main

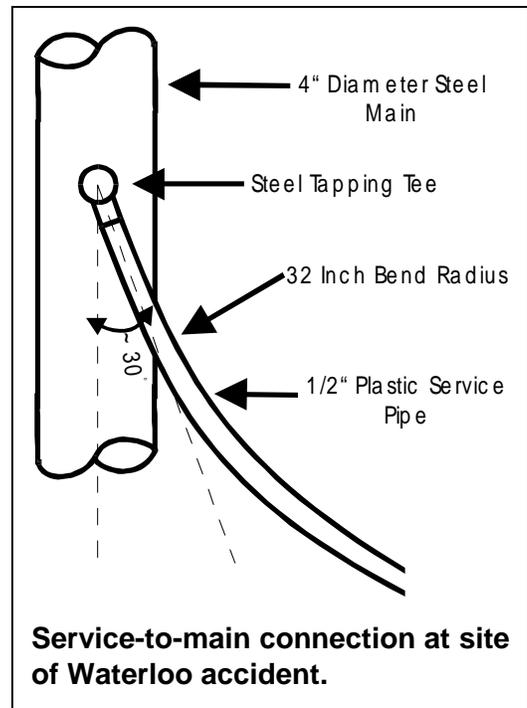
Service-to-main connection at site of Waterloo accident.

MidAmerican Energy estimated that the steel tee on the steel main was installed so that the polyethylene pipe exited the tee at an approximate 30° angle to the steel main. (See figure.)

The plastic service pipe leaving the tee immediately curved horizontally. After a portion of the pipe was taken to the laboratory for testing, the bend radius was measured at about 34 inches. Based on field conditions and photos, MidAmerican Energy has estimated the original installed horizontal bend radius to be approximately 32 inches.³ This bend is sharper than currently recommended by industry guidelines for modern piping adjacent to fittings. However, a former Iowa Public Service Company employee stated that Iowa Public Service Company, in an effort to reduce the stress at the connection point, often attempted to install polyethylene services at an angle to the main to match the residual bend left after uncoiling the pipe.⁴ This former employee stated that no set time was prescribed to allow for complete relaxing of the pipe, but that the pipe would be placed in the ditch, and the crews would weld the tee at what they judged to be the appropriate angle, in consideration of the natural bend of the pipe.

Also immediately from the tee outlet, the polyethylene bent downward. The tee outlet did not have a protective sleeve to reduce shear and bending forces at the connection.

The fracture in region A was located immediately outside the tee's internal stiffener. The crack was perpendicular to the pipe wall and directly in line with the end of the tee's internal stiffener. The inside surface of the pipe throughout region A was characterized by a circumferential impression from the tip of the tee's stiffener. A similar impression was not found in region B. This impression was only found on the pipe segment that was still attached to the steel tee, and was not evident on any part of the pipe segment that was detached from the steel tee. Region A was characterized by several brittle-like slow crack growth fractures, each of which initiated on or near the pipe inner wall just outside the depression associated with the tip of the tapping tee's stiffener. These slow crack fractures propagated on almost parallel planes slightly offset from each other through the wall of the pipe. As the cracks from different planes continued to grow and began to overlap one another, ductile tearing occurred between the planes, which produced a jagged appearance in parts of the overall circumferential crack in region A. Thus, even though substantial deformation was observed in part of the fracture, the initiating cracks were still classified as brittle-like.

Region B contained two brittle-like crack growth sections that initiated from each end of region A. Cracks from each end of region A propagated through region B on approximate 45° planes towards the tee (partially exposing the tee's stiffener) and met at the bottom (the 6:00 position). The remaining ligament tore with visible deformation at the bottom.

Laboratory comparisons showed that the fractures that initiated and grew in region A were consistent with fractures generated by long-term shear and bending forces at the end of the stiffener. The fractures in region B were consistent with a continuation of the same loading system described for region A but occurred subsequent to those in region A. The last ligament that fractured at the 6:00 position in region B was consistent with ductile tearing. Examination could not determine whether the last remaining ligament tore because of concentrated stresses prior to the excavation or because of excavation activities after the accident.
