Enbridge Incorporated  
Hazardous Liquid Pipeline Rupture and Release  
Marshall, Michigan  
July 25, 2010

NTSB/PAR-12/01  
PB2012-916501

# Pipeline Accident Report

**National Transportation Safety Board. 2012. *Enbridge Incorporated Hazardous Liquid Pipeline Rupture and Release, Marshall, Michigan, July 25, 2010. Pipeline Accident Report NTSB/PAR-12/01. Washington, D.C.***

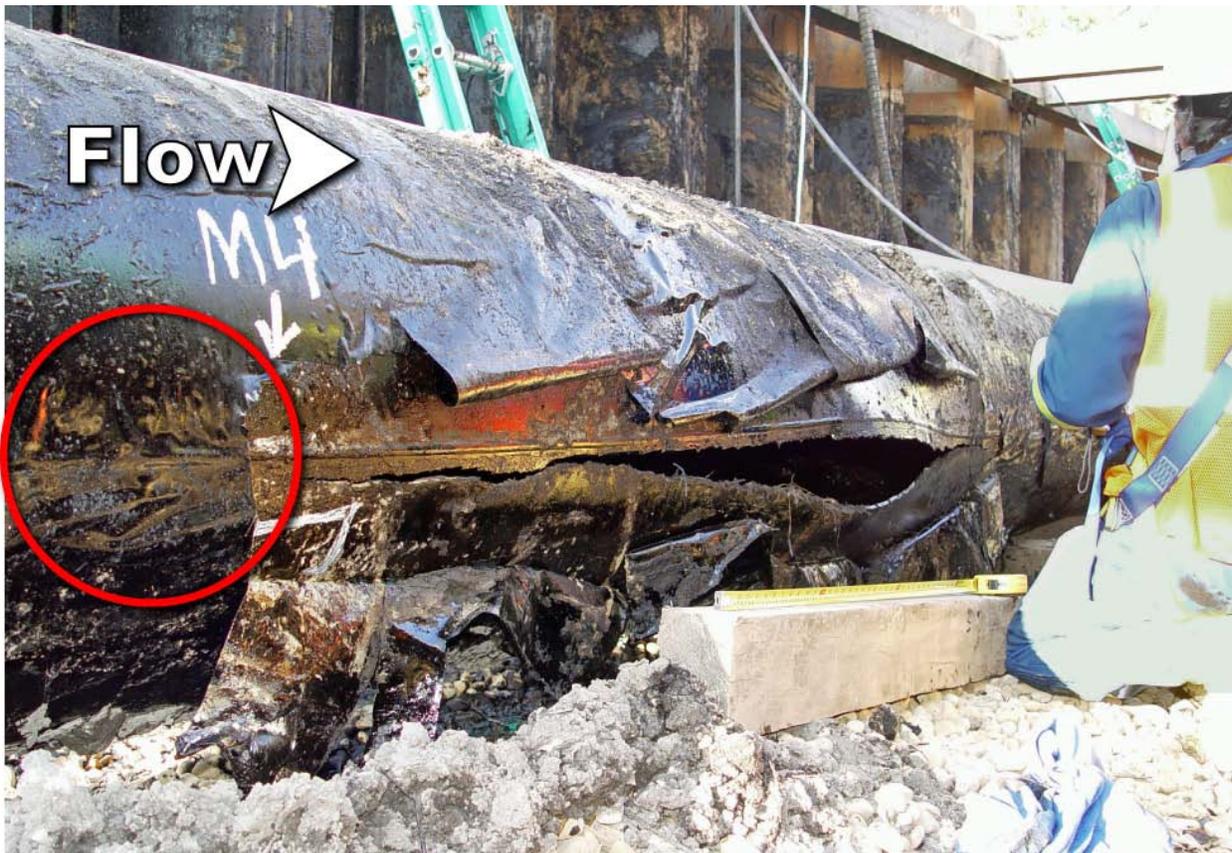
The fracture in the ruptured segment measured 6 feet 8.25 inches long and up to 5.32 inches wide. (See figure 2.) External corrosion was present along the longitudinal weld seam and in areas where the adhesive bond between the pipe and its protective polyethylene tape coating had deteriorated (disbonded). The coating was wrinkled and had separated from the pipe surface as shown in the red circle in figure 2.

**Figure 2.** The ruptured segment of Line 6B in the trench following the July 25, 2010, rupture. The fracture face measured about 6 feet 8.25 inches long and was 5.32 inches wide at the widest opening. The fracture ran just below the seam weld that was oriented just below the 3 o'clock position. A red circle shows a location where the coating was wrinkled and had separated from the pipe surface.

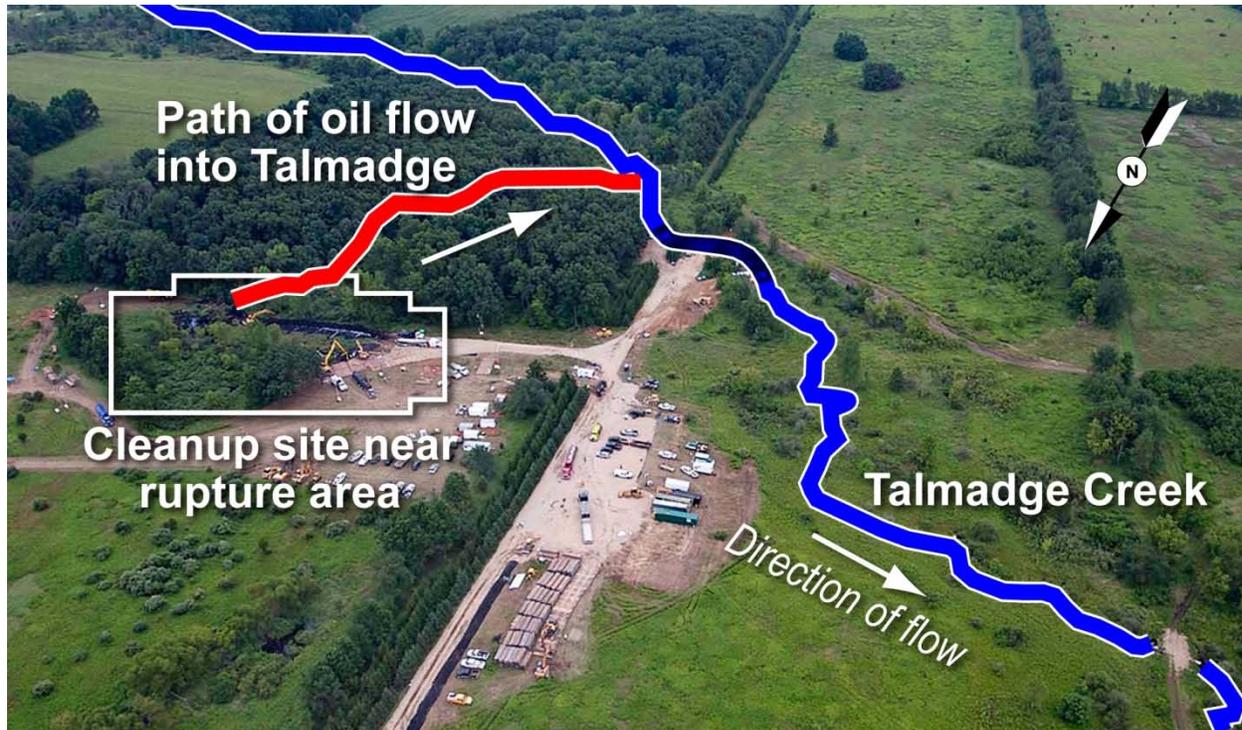
The crude oil release soaked the rupture site and the surrounding wetlands, eventually spreading to the Talmadge Creek and the Kalamazoo River. Enbridge's early response efforts were focused downstream of the rupture. Recent heavy rainfall had increased the flow of the Talmadge Creek and the Kalamazoo River, which spread the oil faster, hindering the response efforts. (See figure 3.)

**Figure 3.** Aerial view of the accident location showing the rupture site to the left and the Talmadge Creek flowing west toward the Kalamazoo River.

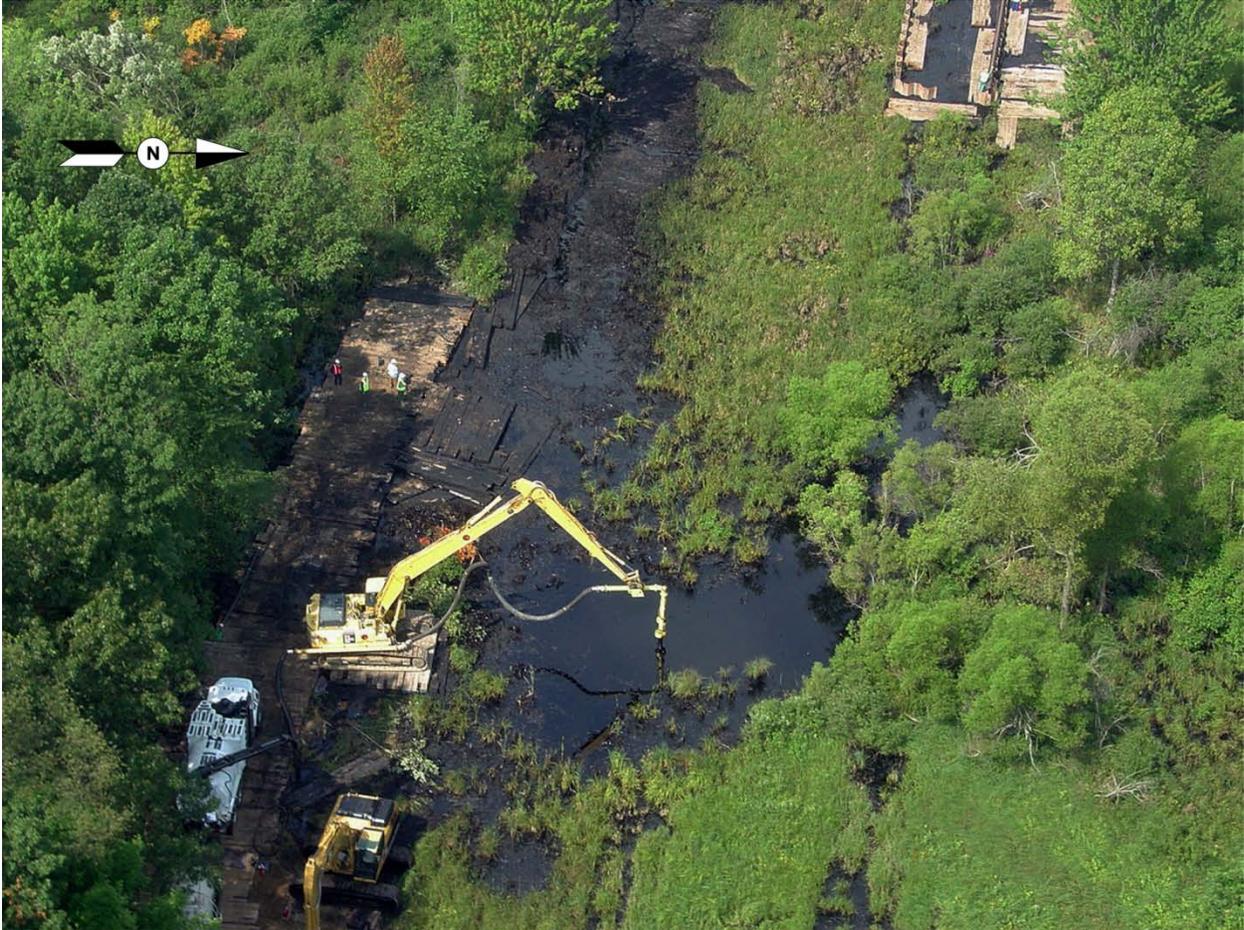
The wetland conditions in addition to the crude oil release made it difficult for vacuum trucks and excavators to get near the rupture location. Large wooden matting had to be placed around the rupture location to bring heavy equipment close to the release. (See figure 4.) The conditions at the accident site also delayed efforts to extract the pipe and to contain the oil near the rupture source.

**Figure 4.** Cleanup efforts in an oil-soaked wetland near the rupture site. Saturated soil complicated the cleanup and excavation efforts. An excavator with a vacuum attachment is shown situated on wooden matting near the rupture site.

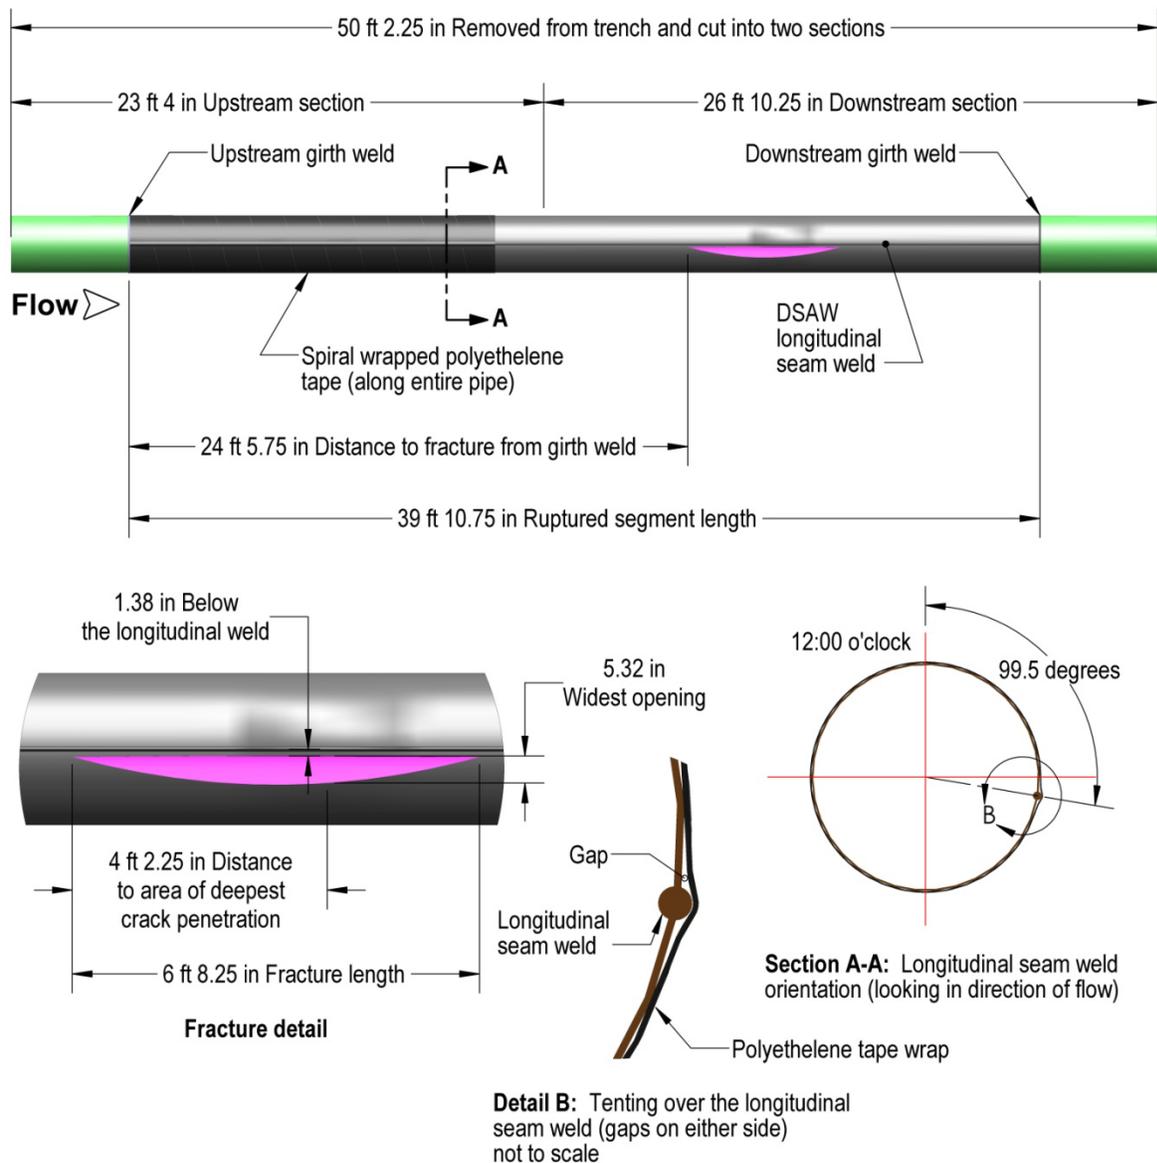
The ruptured pipe segment was 39 feet 10.75 inches long. The longitudinal seam was oriented at 99.5° clockwise.<sup>43</sup> A 50-foot length of pipe that included the rupture was removed and cut into two sections for shipping to the NTSB's Materials Laboratory for examination. The upstream section measured 23 feet 4 inches. The downstream section measured 26 feet 10.25 inches. (See figure 11.)

**Figure 11.** Line 6B ruptured segment showing upstream and downstream sections used for Materials Laboratory examination. Detail B shows tented coating over the longitudinal seam weld.

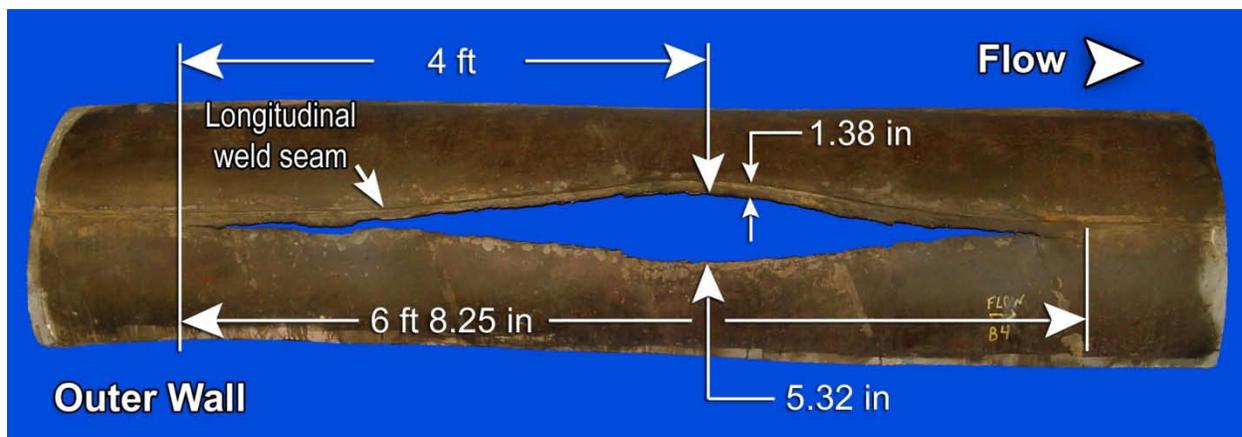
The fracture measured 6 feet 8.25 inches in length with the upstream end of the fracture located 24 feet 5.75 inches away from the upstream girth weld. The widest point along the fracture measured 5.32 inches and was about 4 feet from the upstream end of the rupture. The upper fracture face at the widest opening was measured at 1.38 inches below the longitudinal seam weld away from the heat-affected zone, with this offset ranging from 0.5 to 1.5 inches below the longitudinal weld seam for the length of the fracture face. (See figure 12.)

**Figure 12.** The outside surface of the pipe looking at the fracture area cut for lab examination.

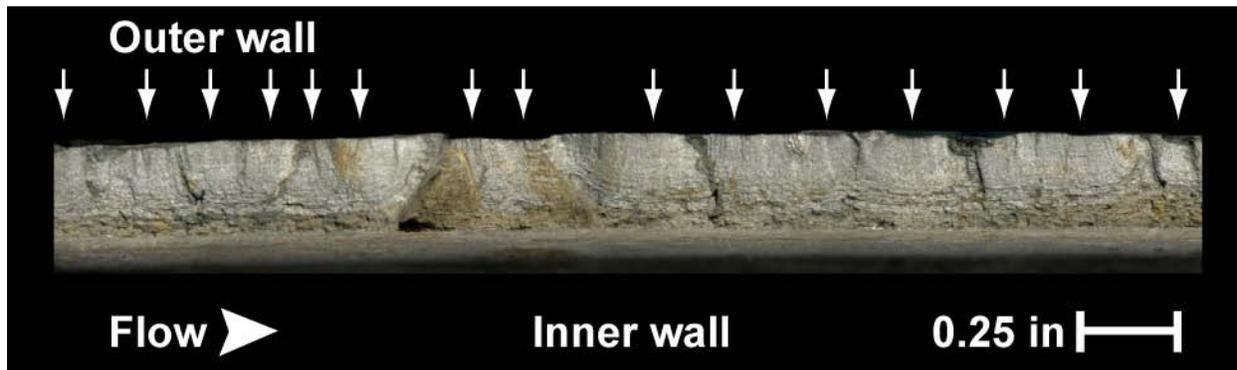
Examination of the fracture face revealed features on slightly offset planes consistent with preexisting cracks initiating from multiple origins in corroded areas on the exterior surface. Evidence of preexisting cracks at various penetration depths was observed across nearly the entire length of the fracture surface. The area of deepest preexisting crack penetration, relative to the original local wall thickness, was located 50.25 inches from the upstream end of the rupture.

**Figure 13.** Curving arrest lines of preexisting cracks along the upper fracture face shown after cleaning to remove oxides. White arrows indicate multiple origin areas of preexisting cracks.

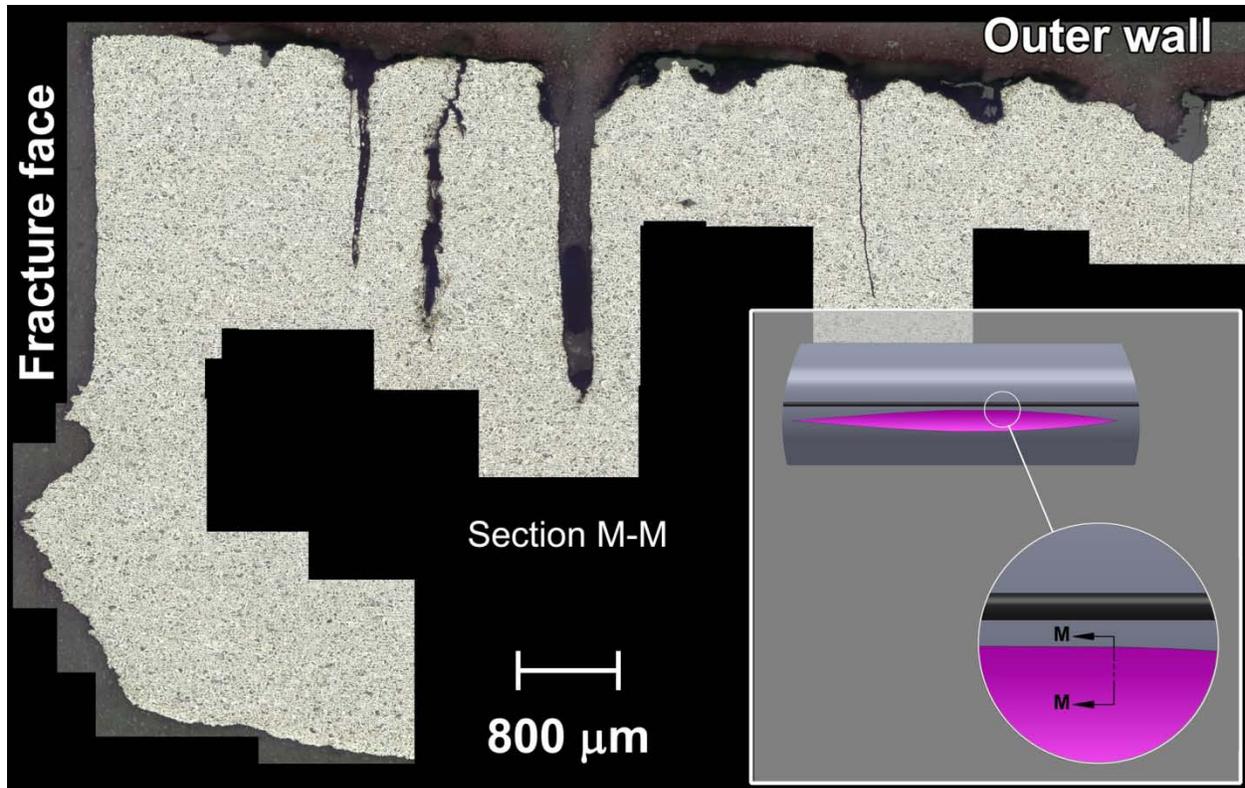
A cross-section through the fracture was prepared as shown in figure 15. The preexisting crack portion of the fracture showed a transgranular<sup>49</sup> fracture path with limited crack branching, consistent with near-neutral pH SCC or corrosion fatigue. Multiple closely spaced and parallel secondary cracks (with transgranular propagation paths and limited crack branching) emanated from corrosion pits on the outside wall near the fracture face, also consistent with corrosion fatigue or near-neutral pH SCC. The deepest secondary crack extended through about 43 percent of the wall thickness.

**Figure 15.** Transverse section through the top of the fracture showing multiple parallel cracks emanating from corrosion pits on the outside surface.

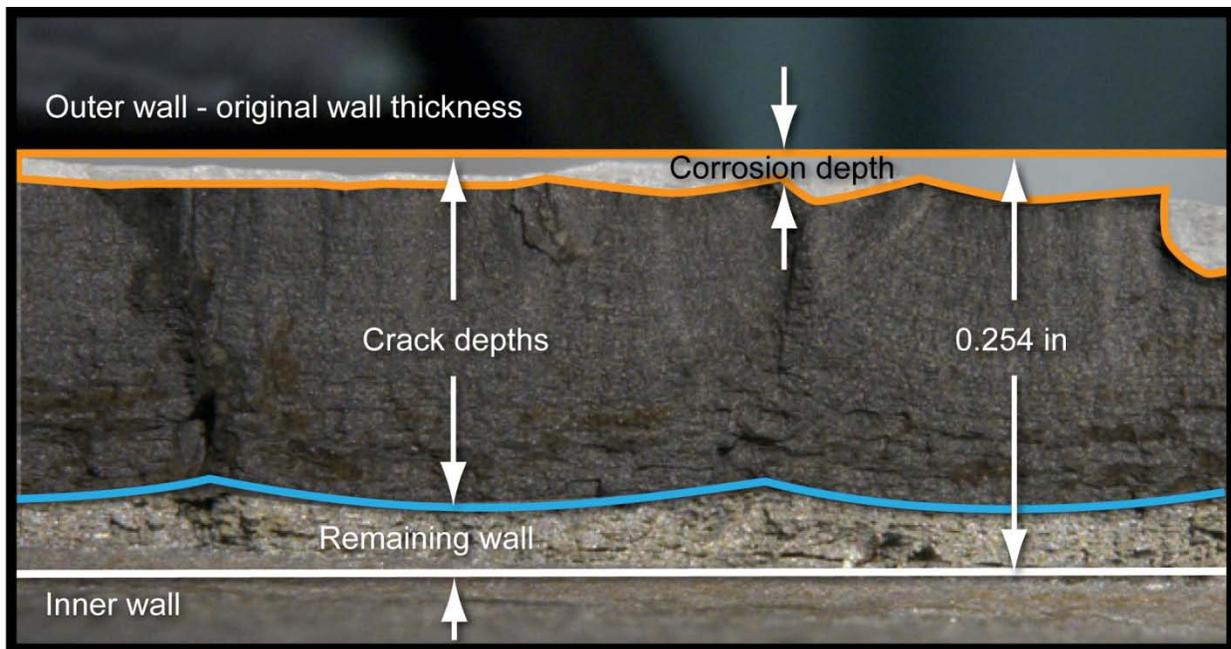
**Figure 16.** Lab measurements of crack and corrosion depths along the fracture face measured from images similar to figure 14 near area of deepest penetration (about 344 inches from upstream girth weld).

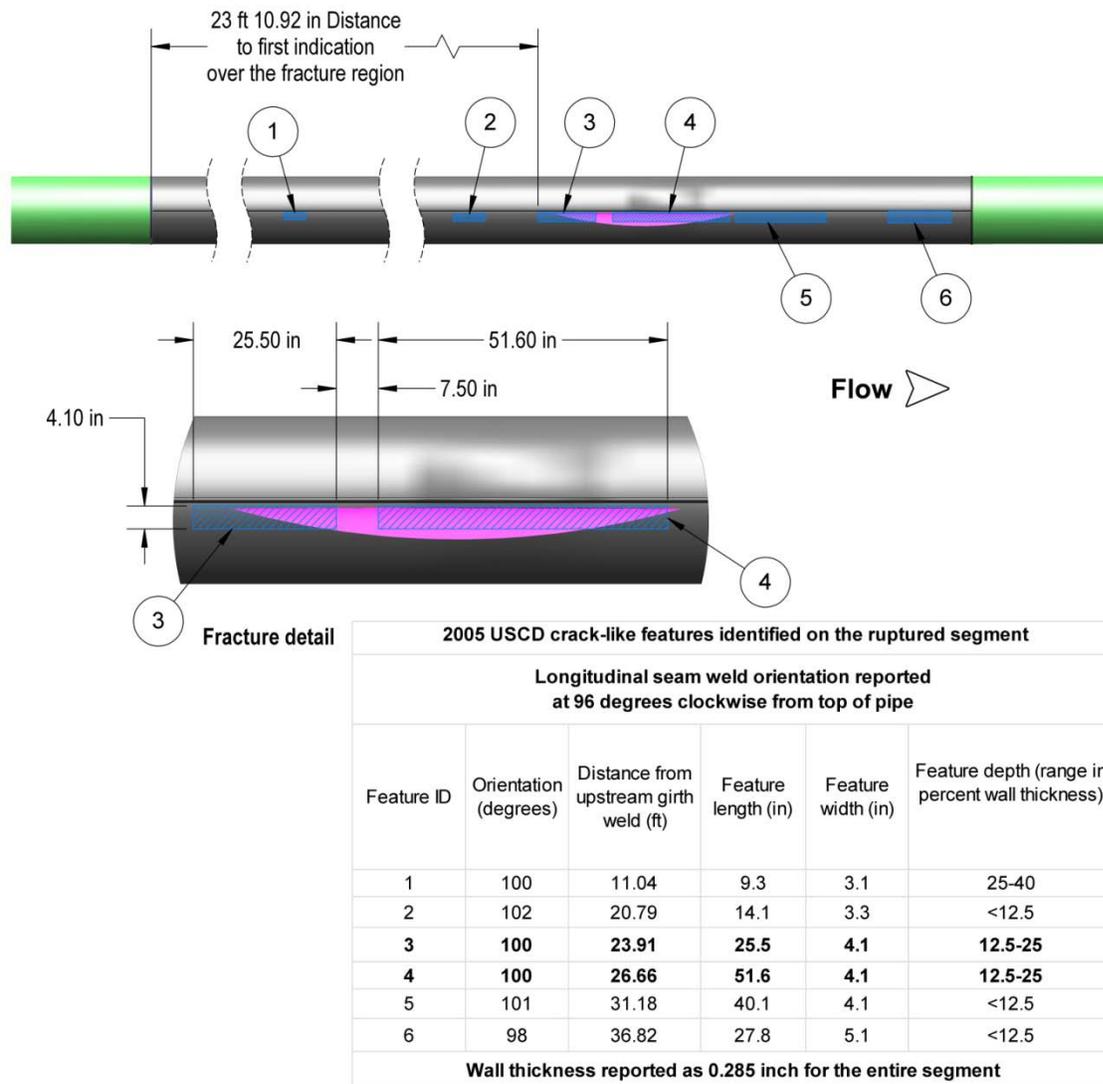
**Figure 18.** 2005 in-line inspection regions where crack-like characterizations were reported by PII on the ruptured segment of Line 6B.

According to PII, all six features identified on the ruptured segment, including the 51.6-inch-long crack, were originally characterized as crack-field indications by a junior analyst; however, a supervisor changed the analyst’s characterizations to crack-like defects during a final quality check.
