Columbia Gas Transmission Corporation Pipeline Rupture
Sissonville, West Virginia
December 11, 2012

NTSB/PAR-14/01

Pipeline Accident Report

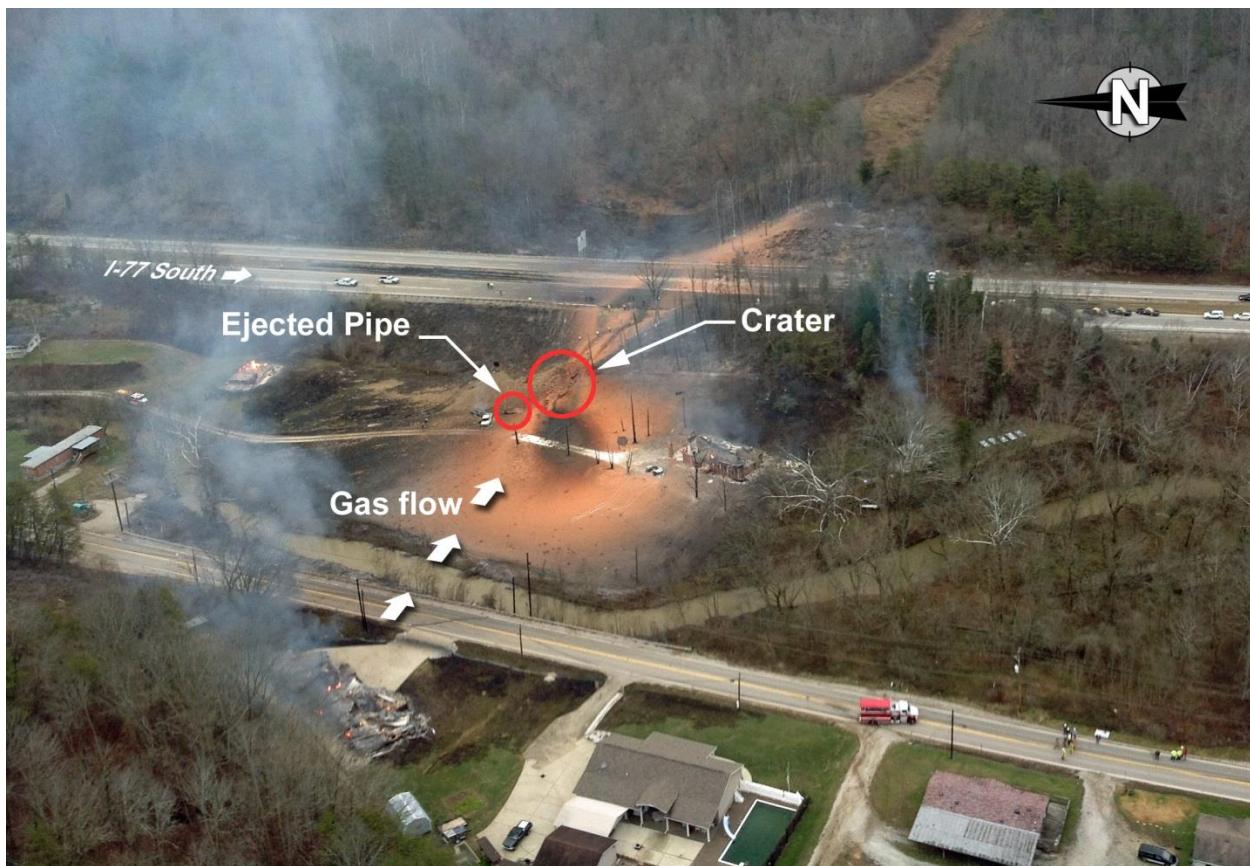
On December 11, 2012, at 12:41 p.m. eastern standard time,¹ a buried 20-inch-diameter interstate natural gas transmission pipeline (Line SM-80), owned and operated by Columbia Gas Transmission Corporation (Columbia Gas), ruptured in a sparsely populated area, about 106 feet west of Interstate 77 (I-77) near Route 21 and Derricks Creek Road in Sissonville in Kanawha County, West Virginia. The pipeline was operating at about 929 pounds per square inch, gauge (psig), just before the rupture. About 20 feet of pipe was ejected from the underground pipeline and landed more than 40 feet away. (See figure 1.)

Figure 1. Accident scene facing east.

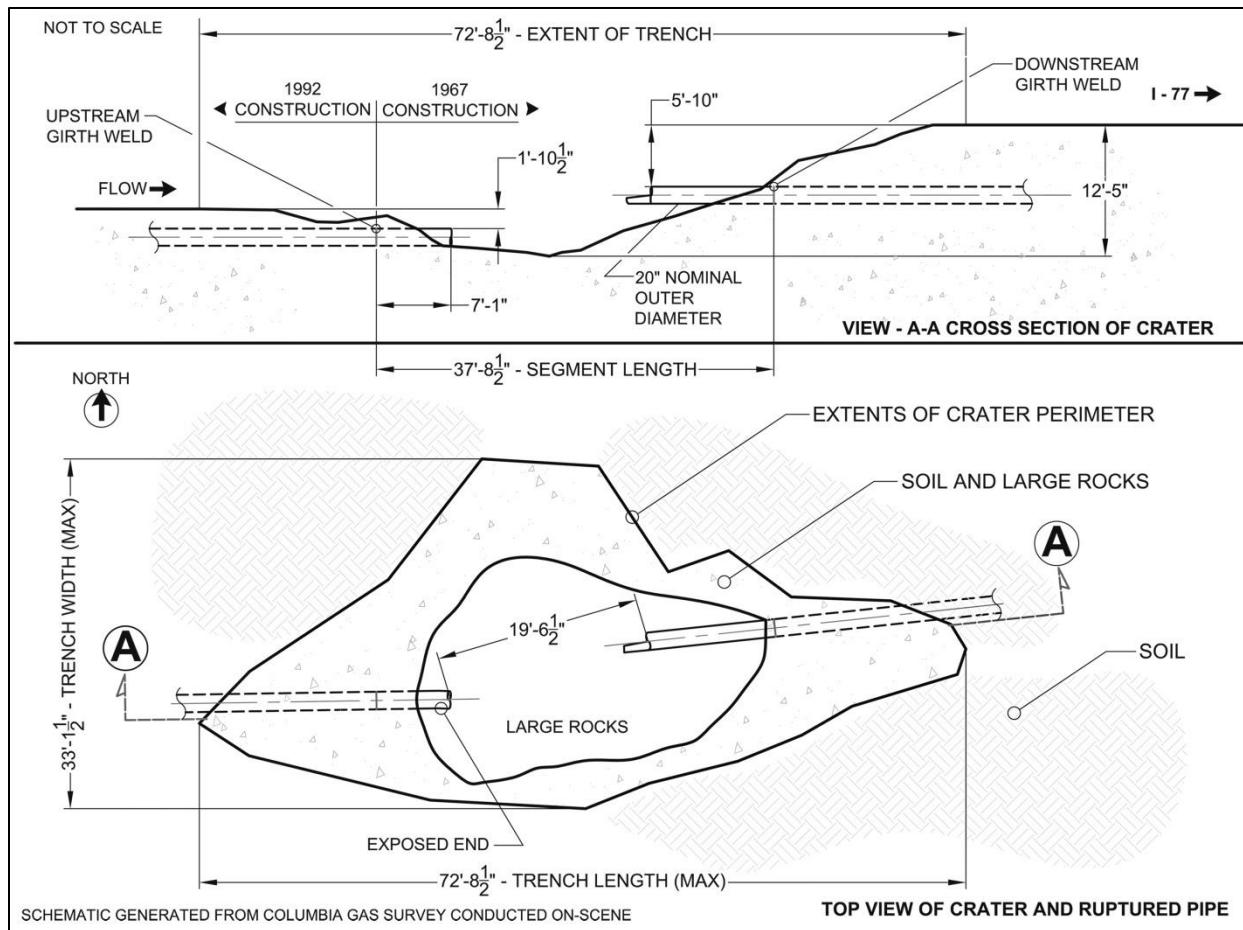
Figure 3. Line SM-80 schematic showing pipeline rupture detail.

The 20-foot-long ejected pipe contained no girth welds. The rupture initiated in an area of heavy external corrosion along the bottom of the pipe that measured about 6 feet in the longitudinal direction and 2 feet in the circumferential direction. The smallest measured wall thickness near the initiation site was 0.078 inch (more than 70 percent wall loss). The pipe fractured in the longitudinal direction along the entire 20-foot length.

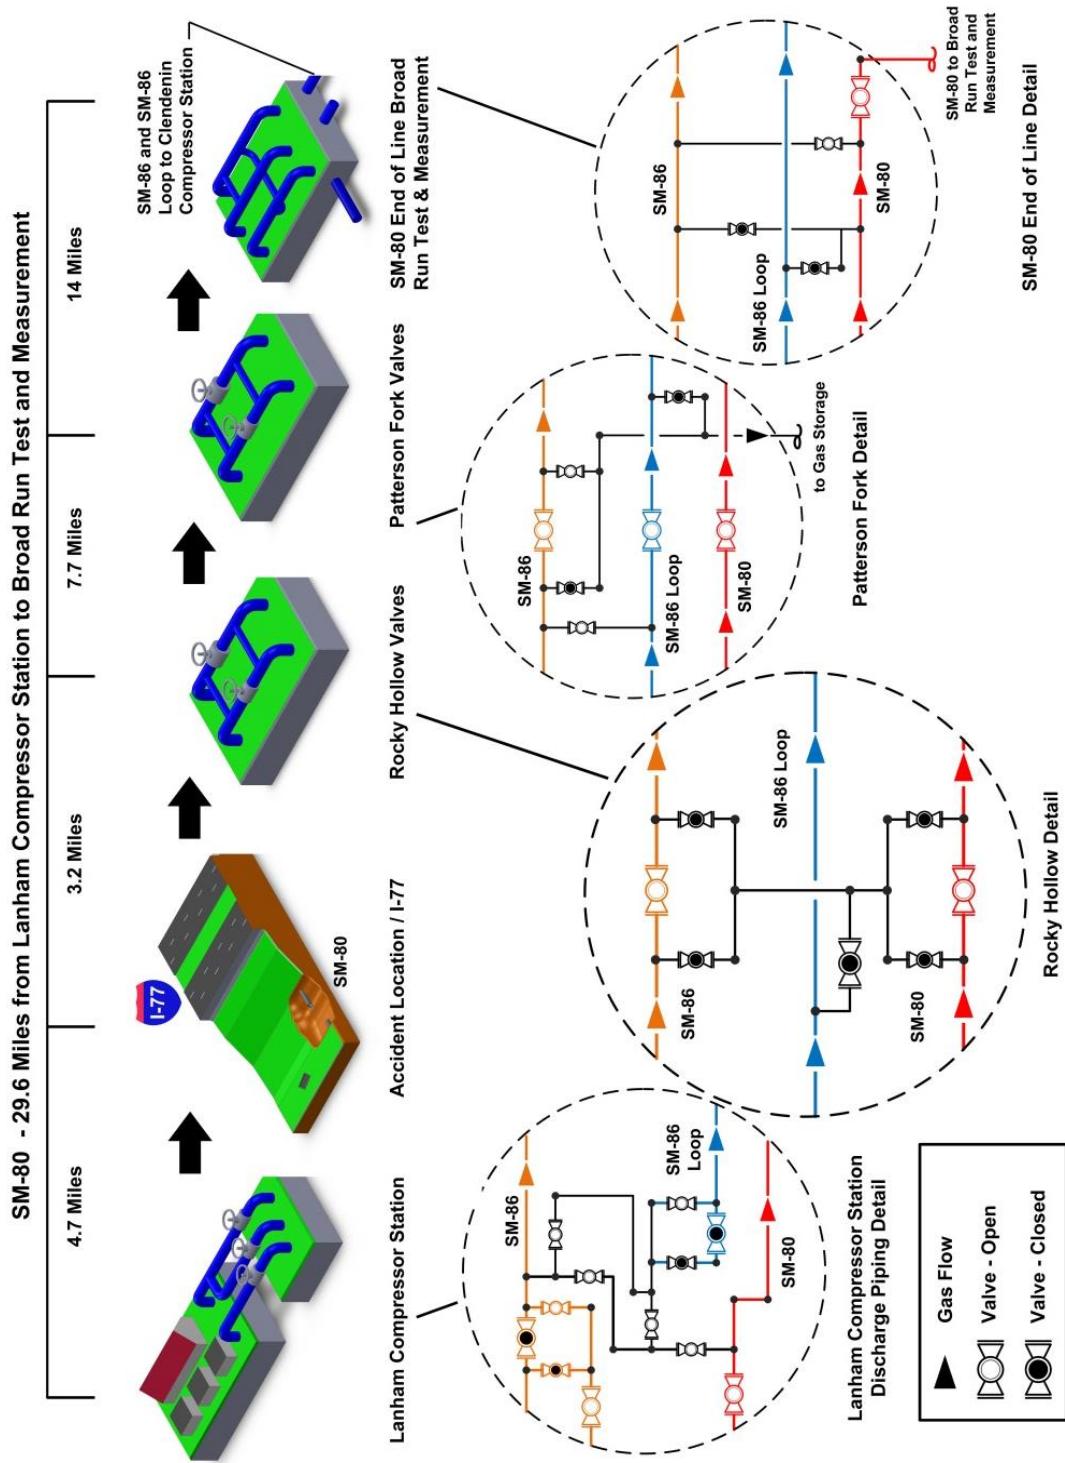
Figure 4. Line SM-80 system schematic showing isolation valve locations and positions at time of rupture.

When the pipeline ruptured, more than 1 hour passed before field personnel completed closing all the SM-80 system valves, which isolated the rupture location from the gas supply. Automatic shutoff valves would most likely have shortened that time. The National Transportation Safety Board (NTSB) first examined how ASVs and RCVs can shorten the duration of the intense gas-fueled fire at a pipeline rupture site in a pipeline accident in Edison, New Jersey, in 1994 (NTSB 1995). Currently, the regulations do not specify a length of time to isolate a ruptured gas line, other than for pipelines with an alternative MAOP.⁸ Furthermore, the regulations give the pipeline operator discretion to decide whether ASVs or RCVs are needed in HCAs as long as the pipeline operator considers the factors listed under 49 CFR 192.935(c).⁹

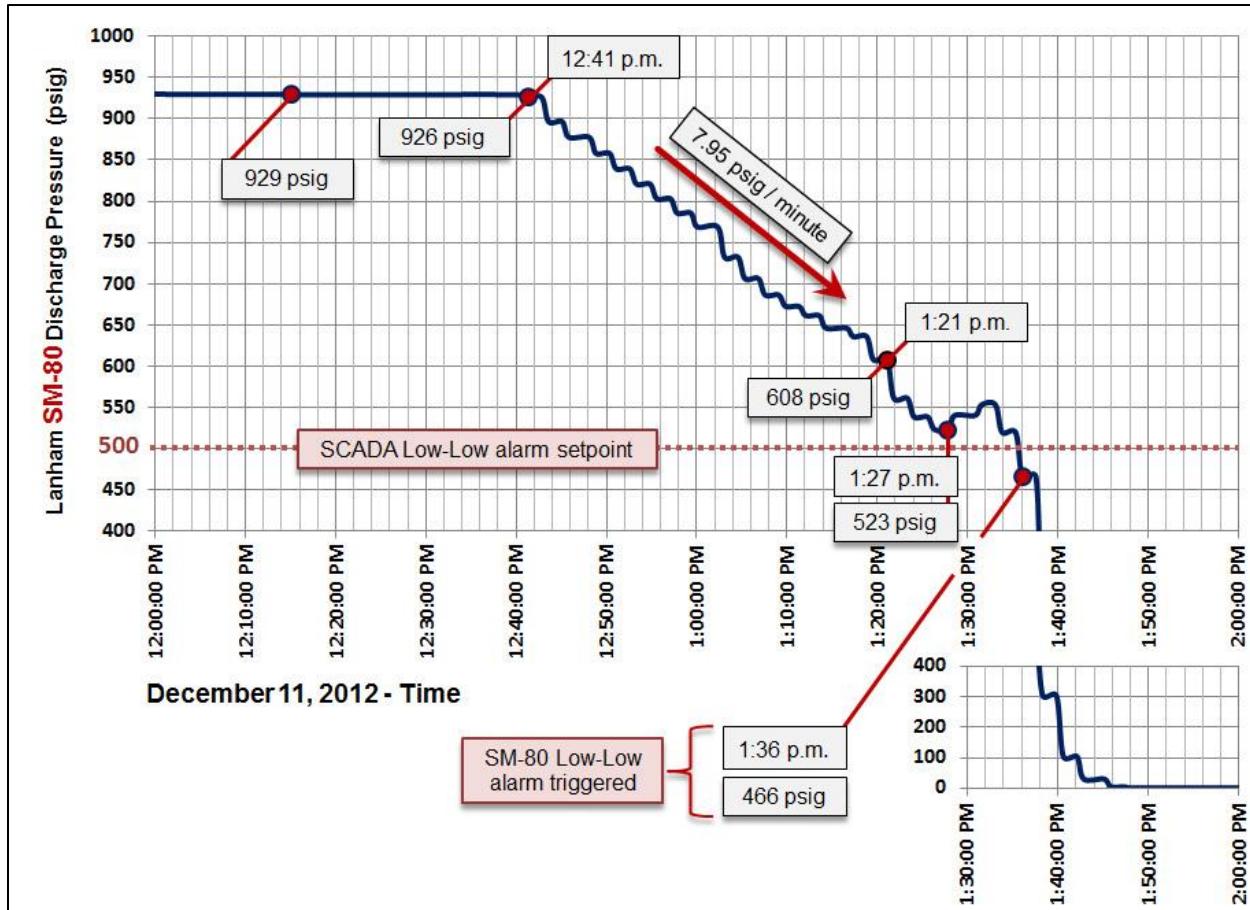
The NTSB investigators examined the SCADA operating records for the day of the accident. Pressure recordings for the Lanham pump station discharge pressures show that at 12:41 p.m. the Line SM-80 discharge pressure began to drop. (See figure 5.) About 12:42 p.m., a Cabot compressor operator who was driving near the accident site called the Cabot control center to report that he had just heard a huge “boom” that “sounded like a bomb going off” and asked whether the control center had received reports of or observed any SCADA system indications that might indicate a problem on the Cabot pipeline system. The Cabot controller told him that the system parameters were normal.

Figure 5. Line SM-80 discharge pressure at Lanham compressor station just before and after the rupture.

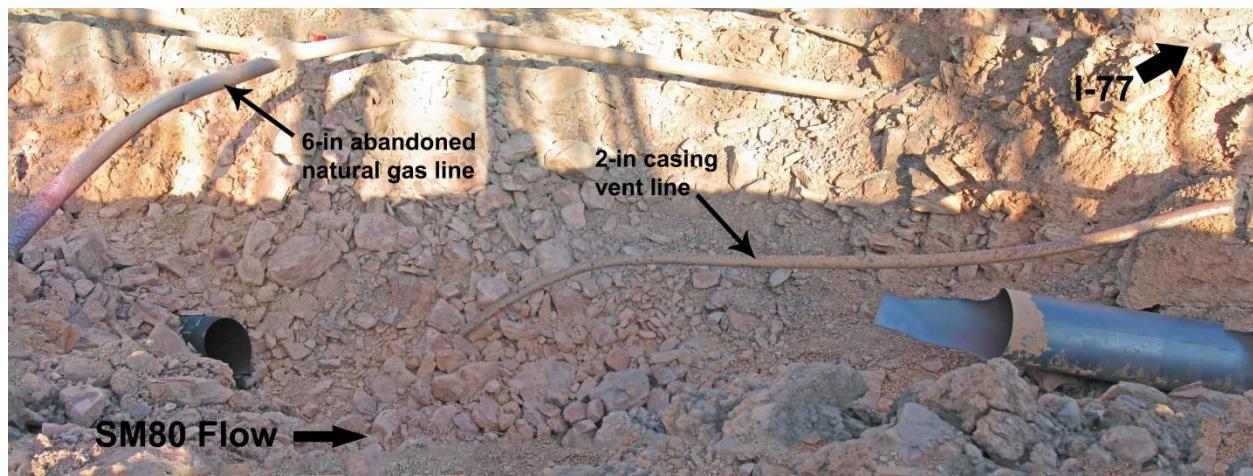
The soil surrounding and in contact with the buried pipe segment in the immediate area of the rupture was very rocky.²² (See figure 6.) The rules for backfilling the trench when the pipe was installed cautioned only against damaging the pipe coating if the backfill material contained large rocks.

Figure 6. Ends of ruptured 20-inch SM-80 pipeline in rocky backfill.

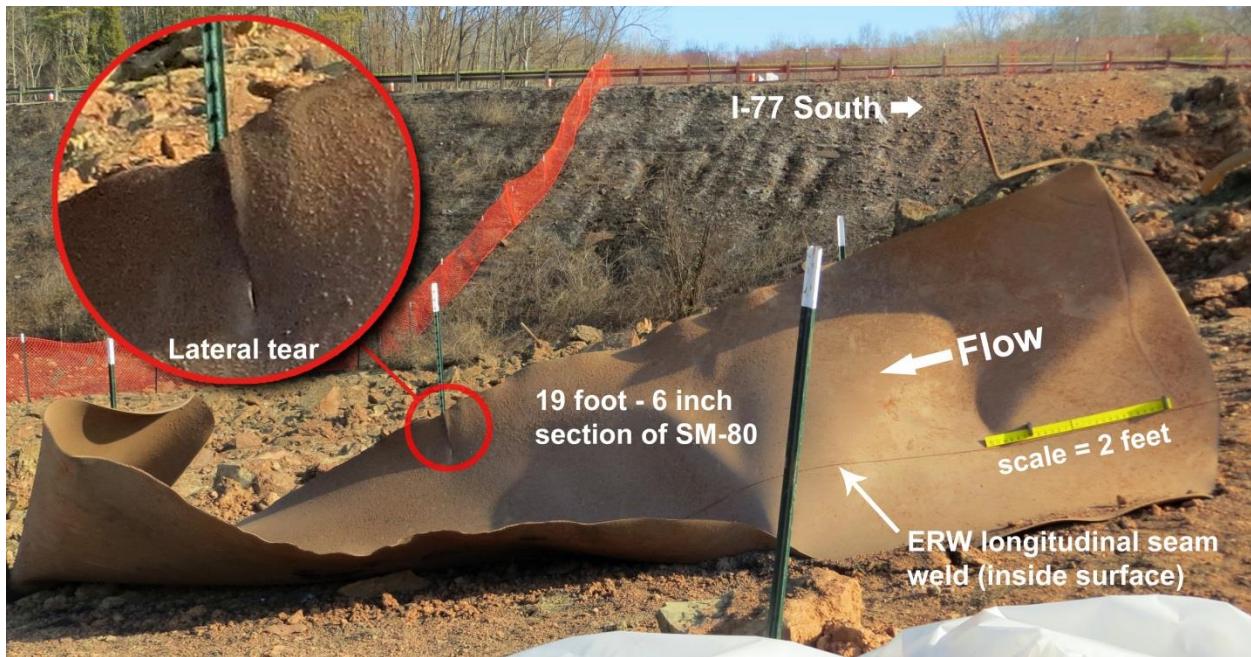
Laboratory measurements indicated that the ruptured pipe joint was 37 feet 8 1/2 inches long and 20 1/2 inches in diameter. The longitudinal fracture was 20 feet 3 inches long. (See figure 7.) Comparing the fracture features of the upstream and downstream ends of the pipe in the crater and the position of the longitudinal seam in the ruptured segment, investigators determined that the longitudinal fracture was near the bottom of the pipe.

Figure 7. Ejected ruptured pipe.

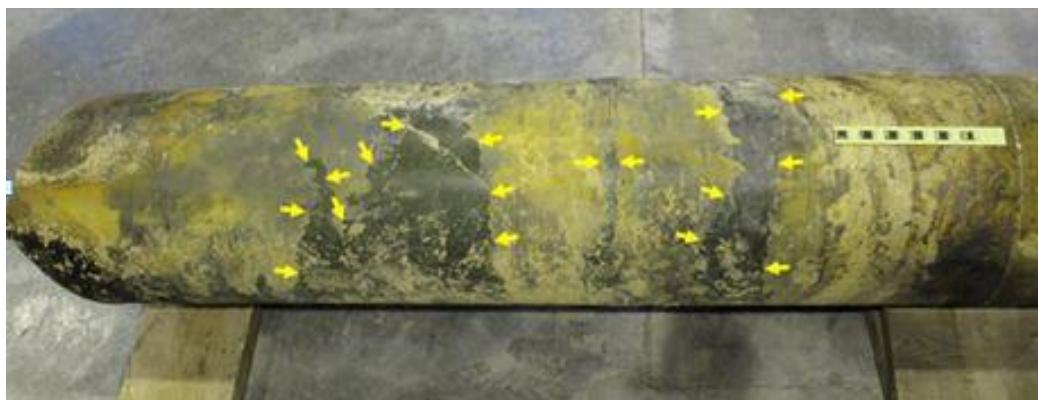
Figure 8. Underside of pipe upstream of rupture exhibiting primarily uncoated pipe. Boundaries of uncoated portion of pipe are indicated by yellow arrows.

The coating coverage varied over the surface of the pipe. Many regions, primarily along the bottom of the pipe, had no protective coating. In other regions, primarily along the sides, the pipe was covered by the green coating but not the coal tar. Along the top of the pipe, the green coating was generally covered by coal tar.

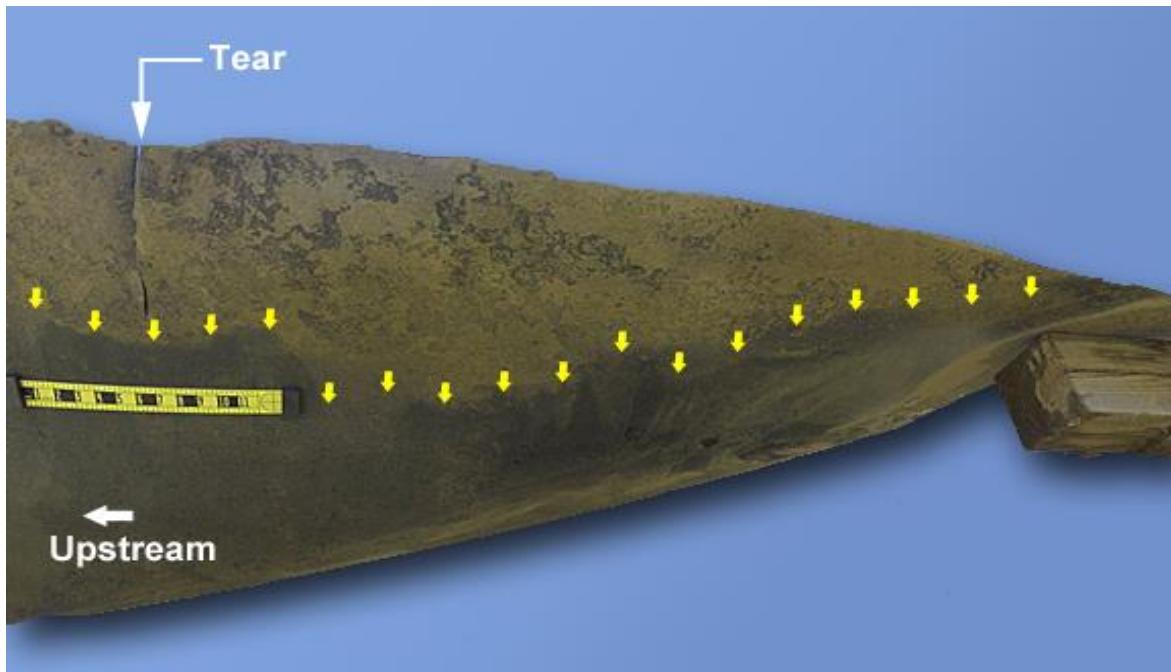
Visual examination of the longitudinal fracture after cleaning showed an area of significant external corrosion damage that was 6 feet 3 inches long and 29 inches wide. (See figure 9.)

Figure 9. External corrosion along longitudinal fracture, with boundary of visible corrosion indicated with arrows.

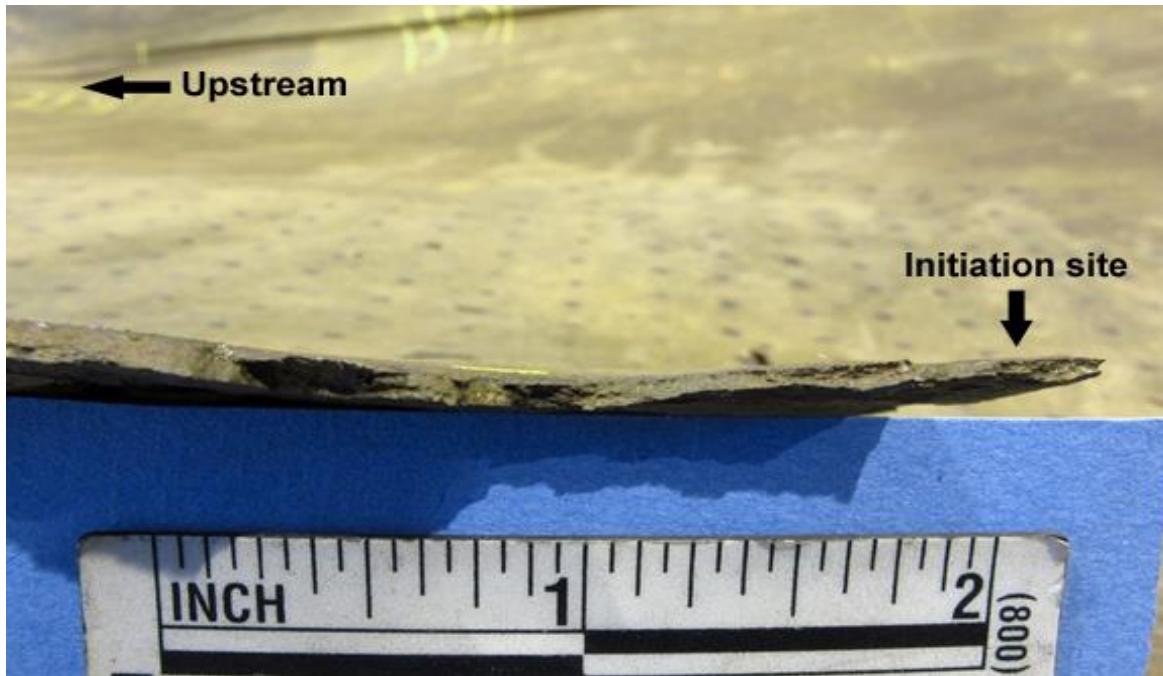
Visual examination of the fracture surfaces determined that the rupture initiated immediately upstream of the lateral tear. The fracture surface had a rough and irregular appearance, features that are consistent with a ductile overstress fracture. The initiation site is shown in figure 10.

Figure 10. Longitudinal fracture surface on upstream side of lateral tear.
