Pipeline Accident Brief

Accident No.: DCA-10-FP-004
Type of System: Natural gas transmission pipeline
Accident Type: Rupture and fire
Location: Cleburne, Texas
Date: June 7, 2010
Time: 2:40 p.m. central daylight time¹
Owner/Operator: Enterprise Products Operating, LLC
Fatalities/Injuries: 1 fatality, 6 injuries
Damage/Clean-up Cost: \$1,029,000
Material Released: Natural gas
Quantity Released: 172 million cubic feet
Pipeline Pressure: 950 pounds per square inch, gauge
Maximum Allowable Operating Pressure: 1,051 pounds per square inch, gauge
Component Affected: 36-inch steel transmission pipeline

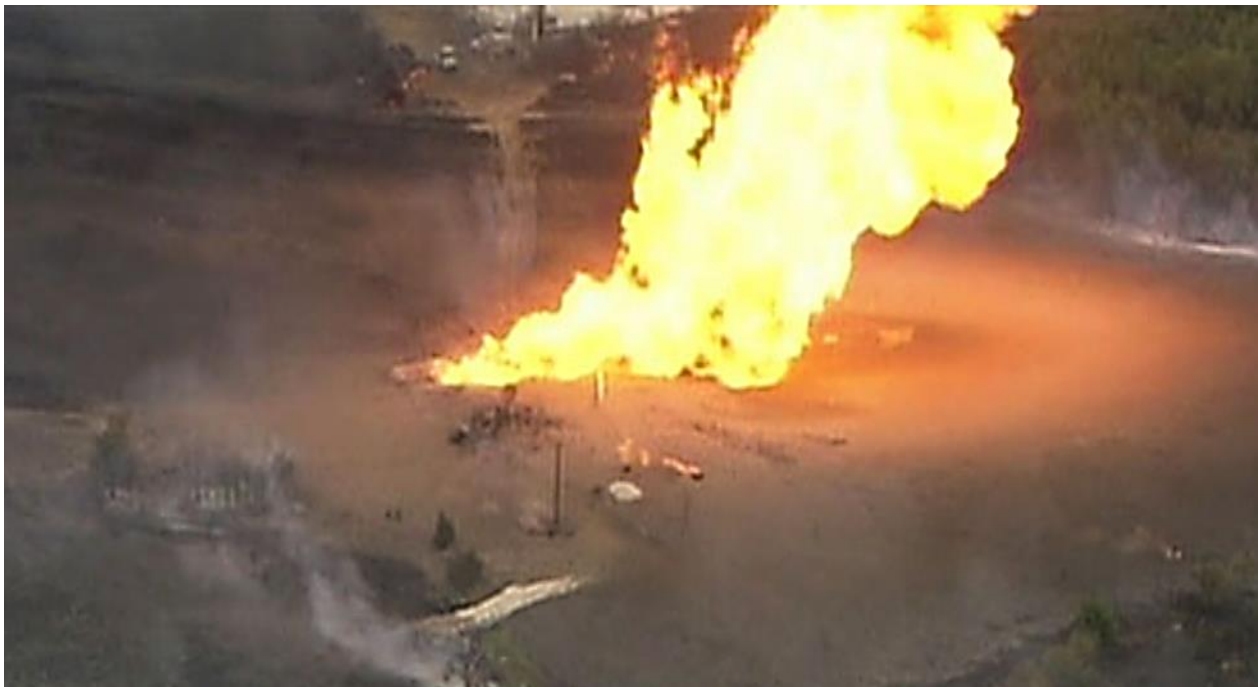
After the C&H auger operator bored to a depth of about 4 feet, the auger punctured the Enterprise pipeline. The eruption of high-pressure gas threw the 60-ton auger truck more than 100 feet and violently ignited. (See figure 1.) The C&H auger truck operator was killed. Six other workers sustained non-life threatening burns from the intense fire. The ET natural gas transmission pipeline was not damaged.

Figure 1. Natural gas burning from 36-inch-diameter Enterprise pipeline

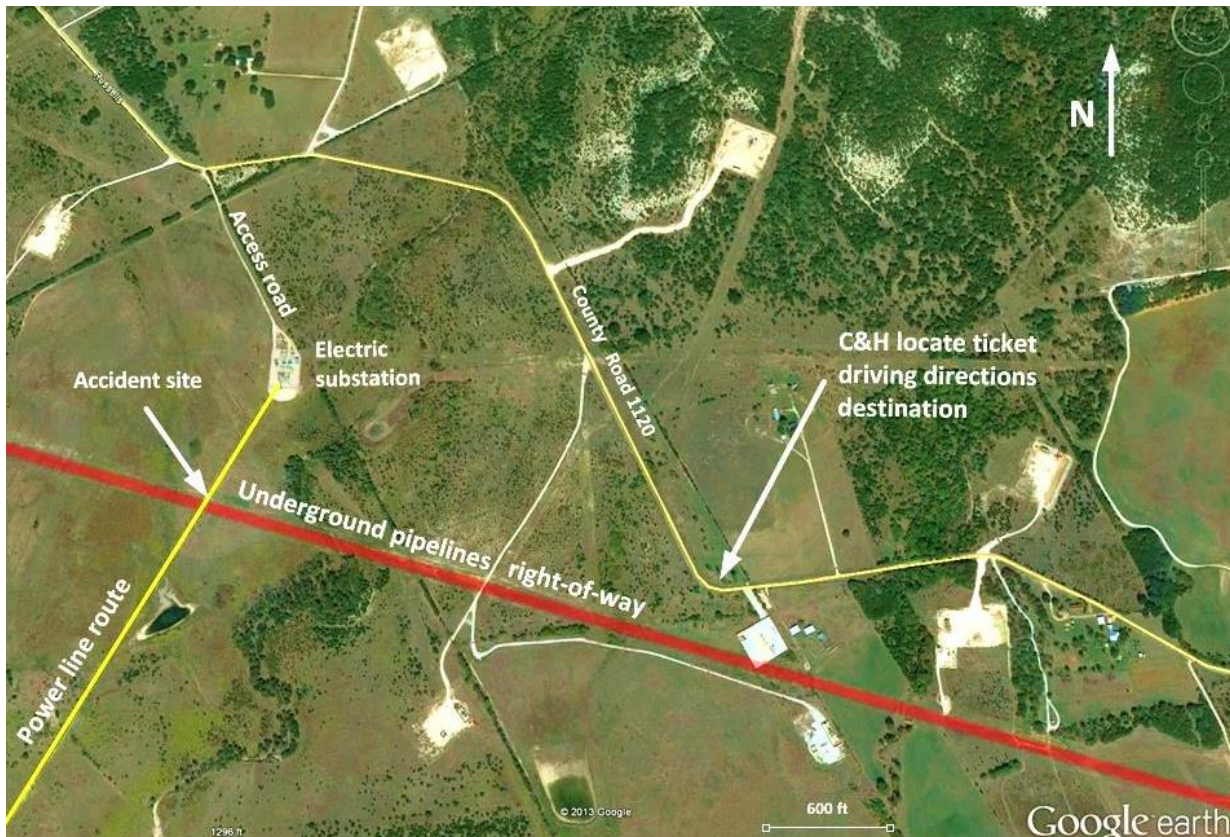
Brazos contracted with Power Engineers to install a 138-kilovolt transmission power line that crossed the right-of-way for the Enterprise and the ET transmission pipelines. (See figure 2.) The right-of-way contained two 36-inch-diameter high-pressure transmission pipelines running

Figure 2. Map showing electric power line route, accident location, pipeline right-of-way, and endpoint of the driving directions on the locate ticket

The final routing map developed by SAM showed the ET pipeline but did not show the Enterprise pipeline in the right-of-way. Had the Enterprise line locator marked the pipeline, it would have been shown on the route map. An accurate route map would have alerted the Brazos and C&H work crews that two underground pipelines crossed the power line route and that both pipelines would have to be marked before they could install the electric power line pole in the pipeline right-of-way.

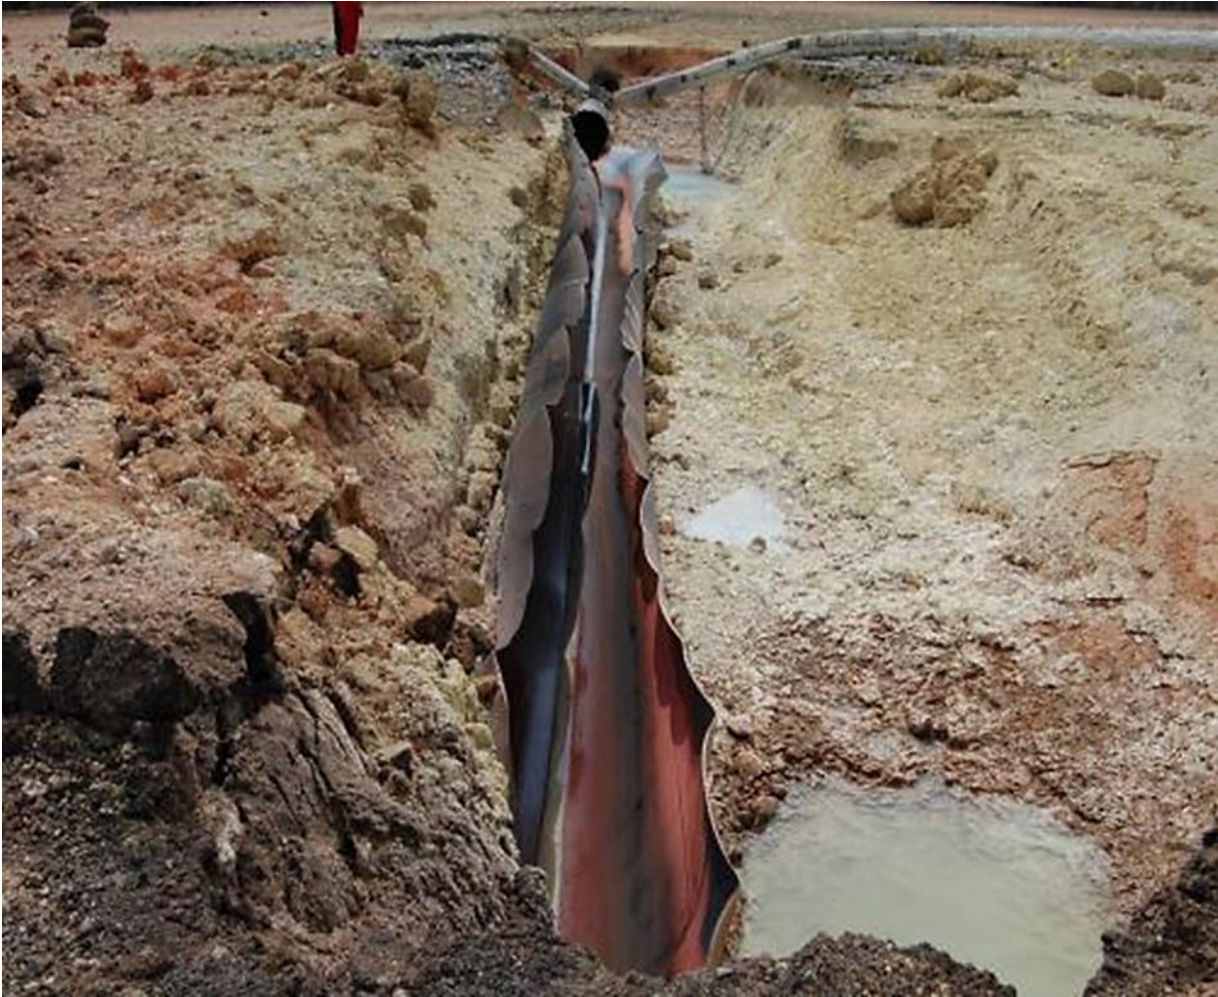
When the C&H boring machine operator proceeded to bore the hole, the auger punctured the Enterprise high-pressure natural gas pipeline. The top of the pipe ruptured and split along a length of about 110 feet. (See figure 3.) The eruption threw the 60-ton auger truck more than 100 feet. (See figure 4.)

Figure 3. Ruptured section, about 110 feet long, of 36-inch-diameter Enterprise natural gas pipeline

- Completed remarking its entire onshore pipeline system in Texas with line-of-sight markers by December 31, 2011.
- Revised its written procedures for permanent line markers to reflect the transition to line-of-sight markers. Instituted line-of-sight markers for active regulated pipelines.
- Revised its written procedures for permanent line markers to reflect the requirement to use line of sight markers.
- Purchased new GPS devices for its employees who perform line-locating tasks.
- Developed in-house training for using the GPS devices for line locating and began training employees during the fourth quarter of 2011.
- Provided classroom instruction and hands-on performance training on the equipment used to locate underground pipelines.
- Developed and implemented standardized in-house training on the use of the utility mapping software.

The National Transportation Safety Board determines that the probable cause of the rupture and fire was a contractor's puncturing the unmarked, underground natural gas pipeline with a power auger. Contributing factors were the lack of permanent markers along the Enterprise Products Operating, LLC, pipeline and the failure of the Enterprise pipeline locator to locate and mark the pipeline before C&H Power Line Construction attempted to install the utility pole in the pipeline right-of-way.

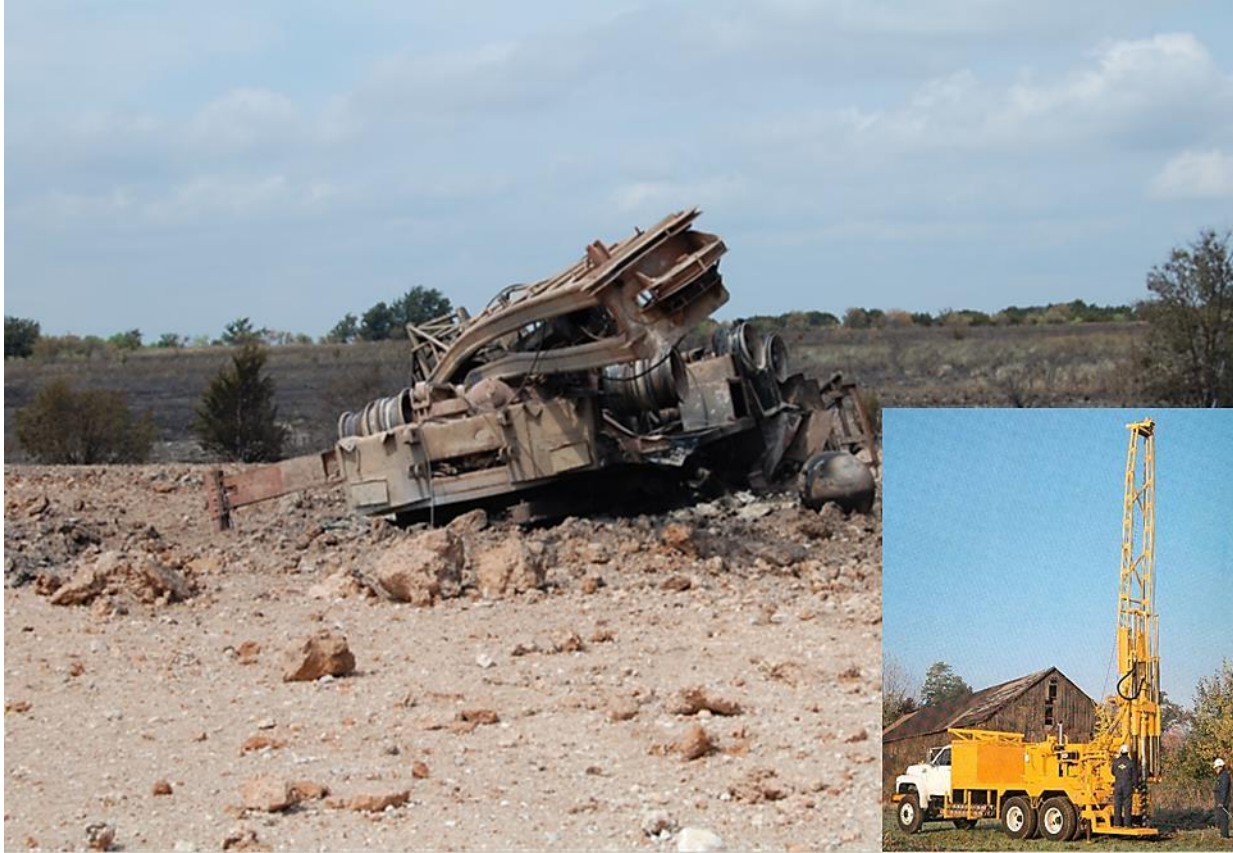
Figure 4. Upside-down, 60-ton C&H auger truck; exemplar truck shown in lower right
