**Response to DTSC Comments on  
Annual 2023 Gas Operation and Maintenance Report and Five-Year Review dated February 2024  
Playa Vista Elementary School (formerly Central Region Elementary School #22), 13150 West Bluff Creek Drive, Los Angeles, CA  
DTSC Comments dated March 27, 2024**

### Subject: Playa Vista Elementary – 2024 Annual Gas Mitigation System Inspection Report

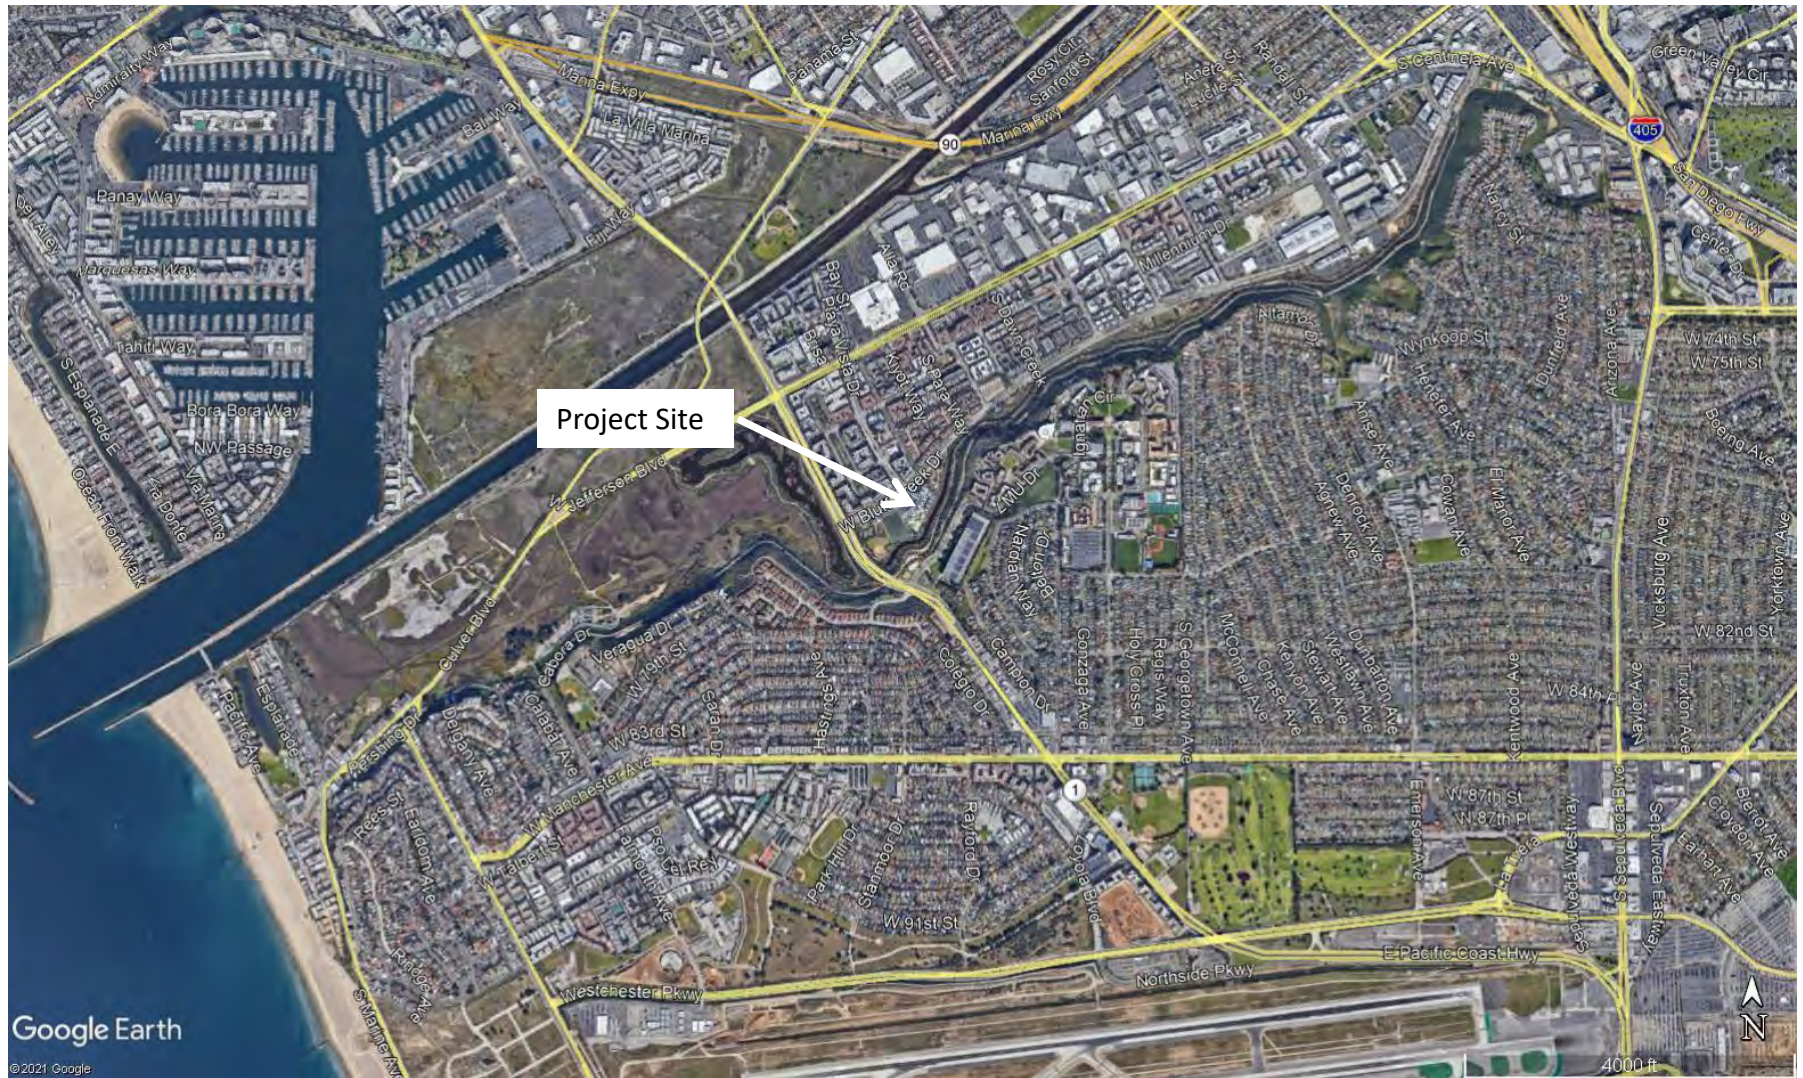
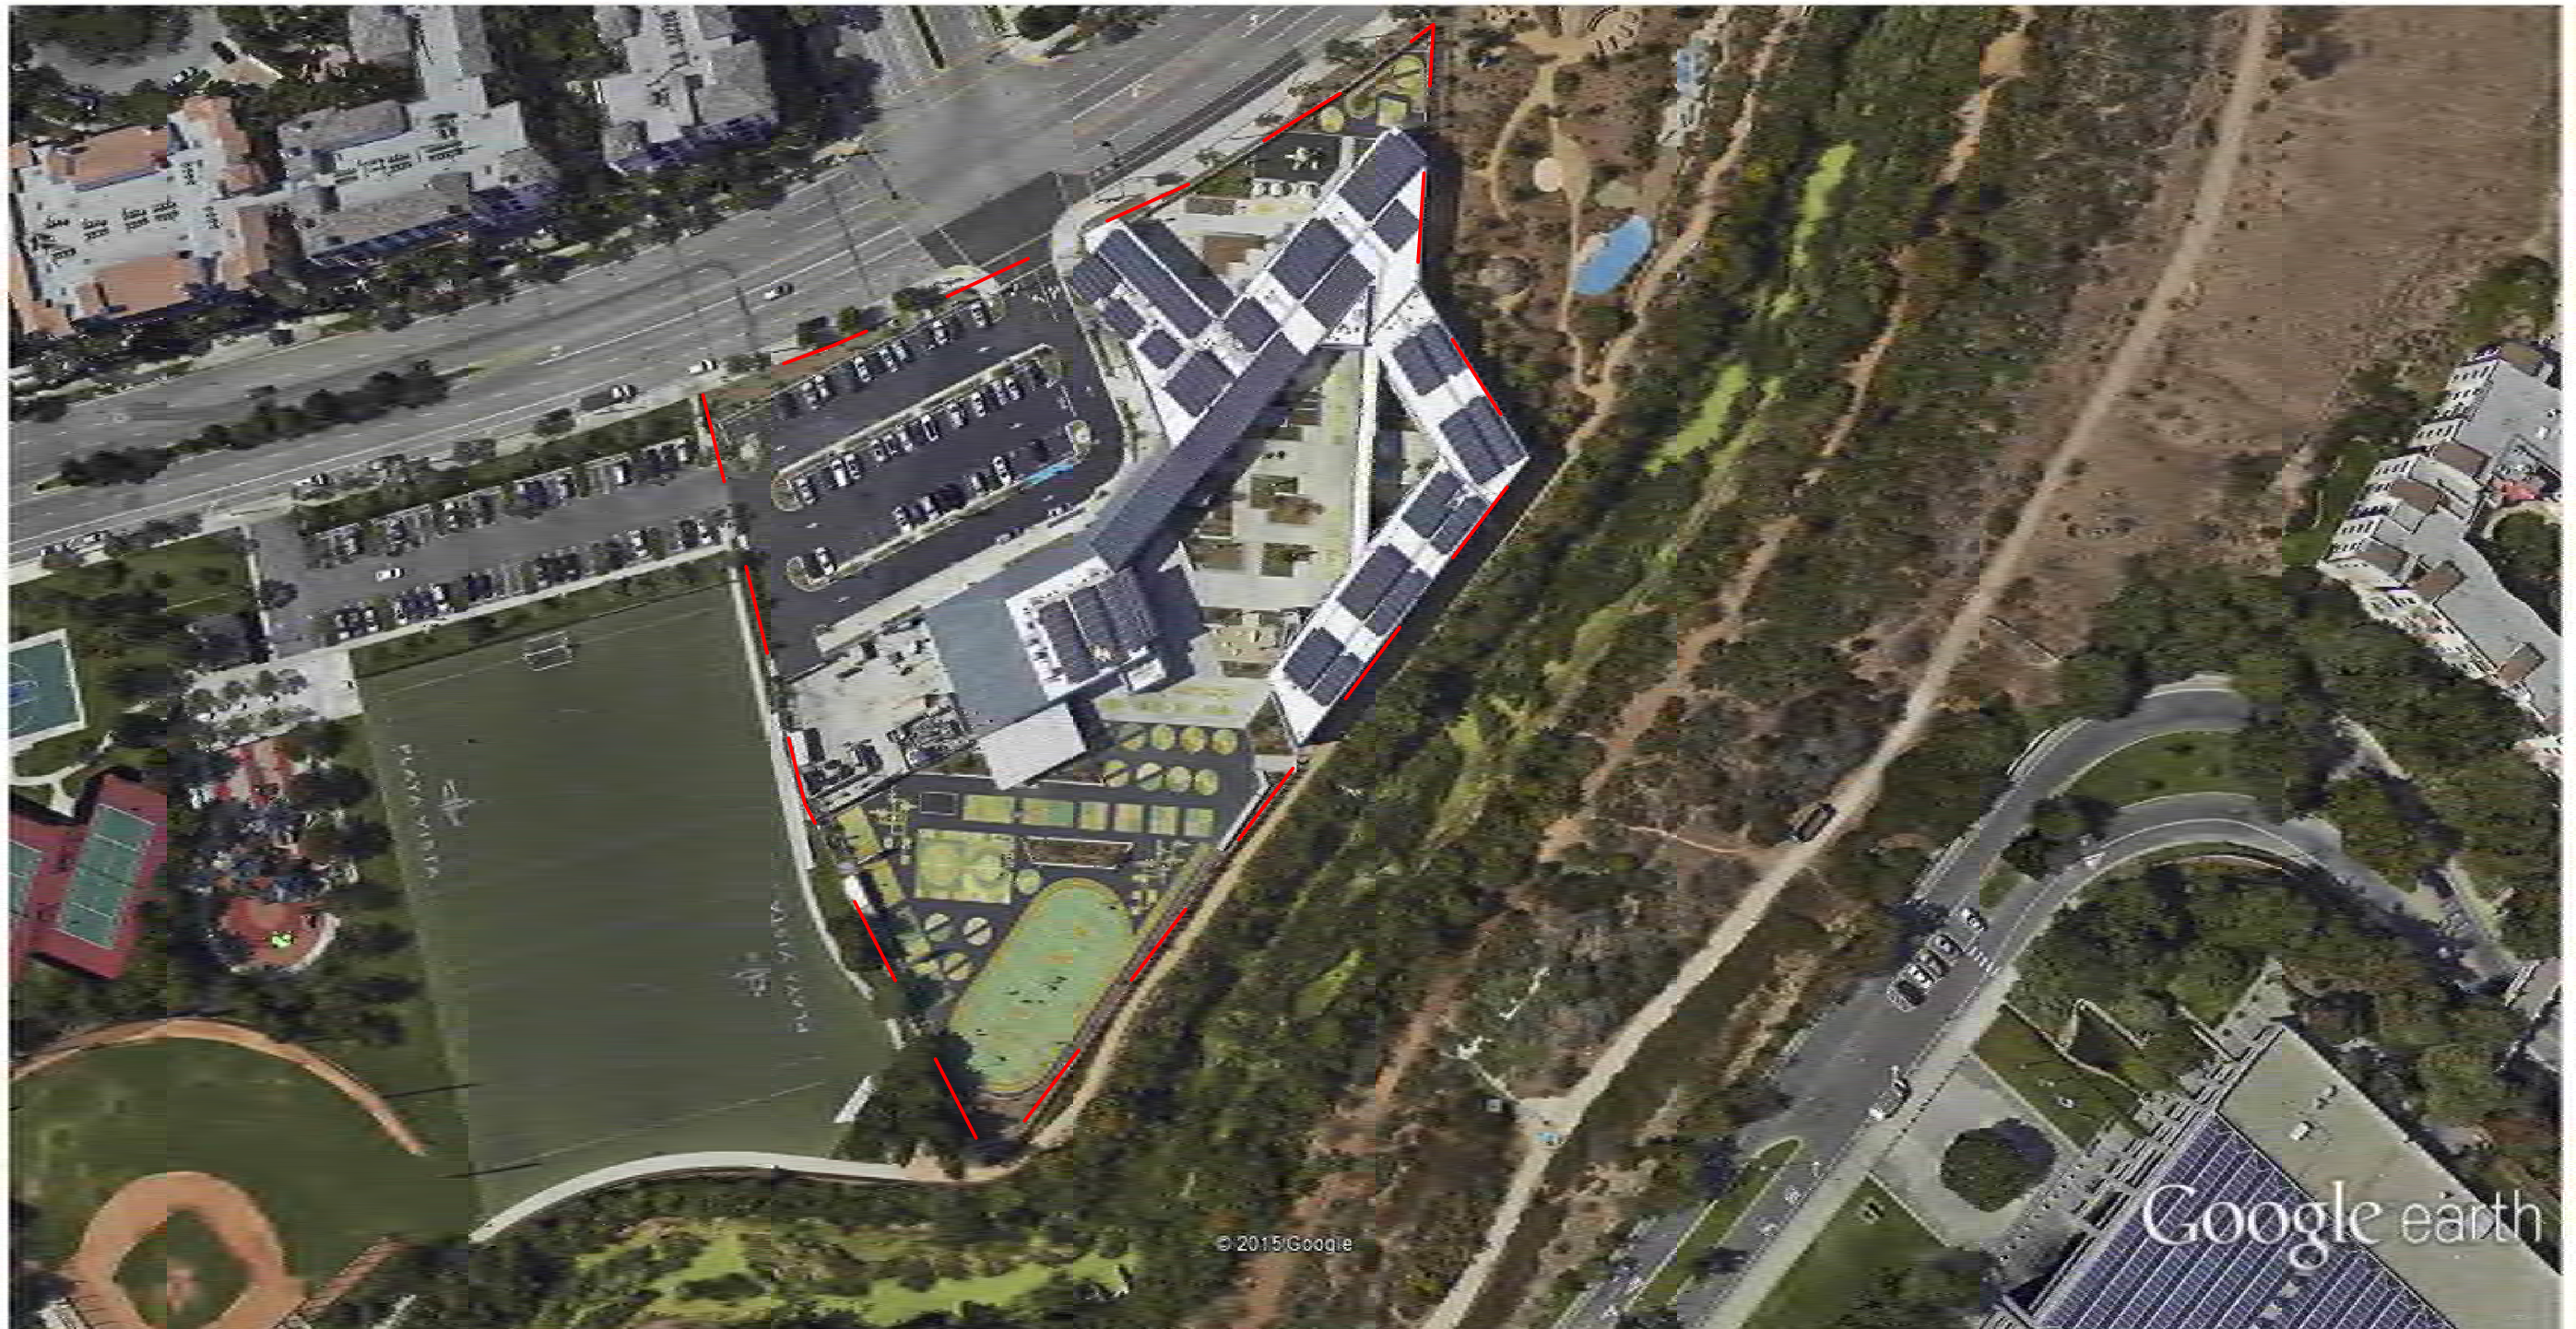
**Figure 1**

**General Site Location**  
**Playa Vista Elementary School**  
13150 West Bluff Creek Drive  
Los Angeles, CA 90094
