Columbia Gas Transmission Corporation Pipeline Rupture
Sissonville, West Virginia
December 11, 2012

NTSB/PAR-14/01

Pipeline Accident Report

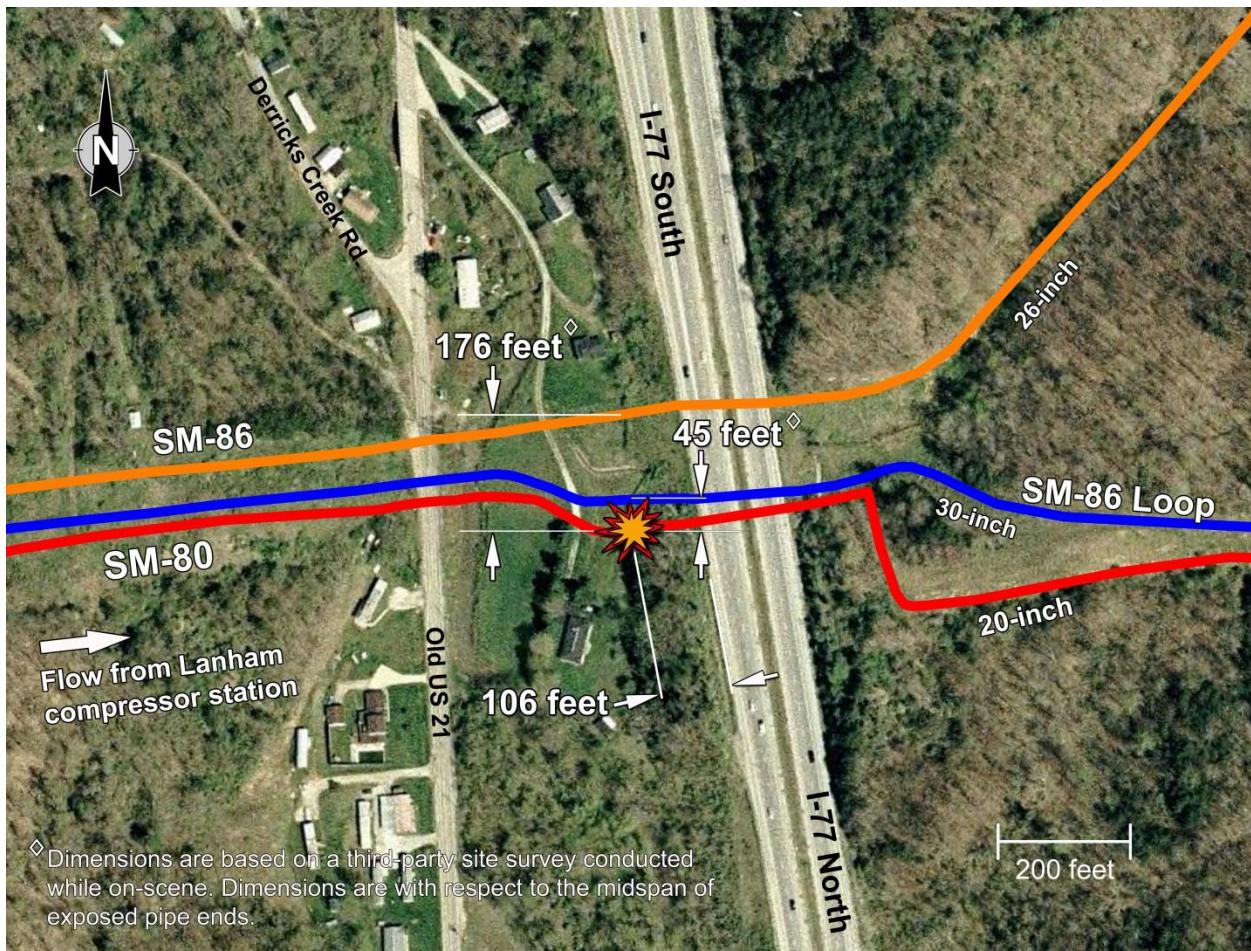
Two other Columbia Gas transmission lines—a 26-inch-diameter pipeline (Line SM-86) and a 30-inch-diameter pipeline (Line SM-86 Loop)—located within the same right-of-way as Line SM-80 were not damaged. (See figure 2.)

Figure 2. Aerial view of the routes of the three SM-80 system pipelines and the rupture location.

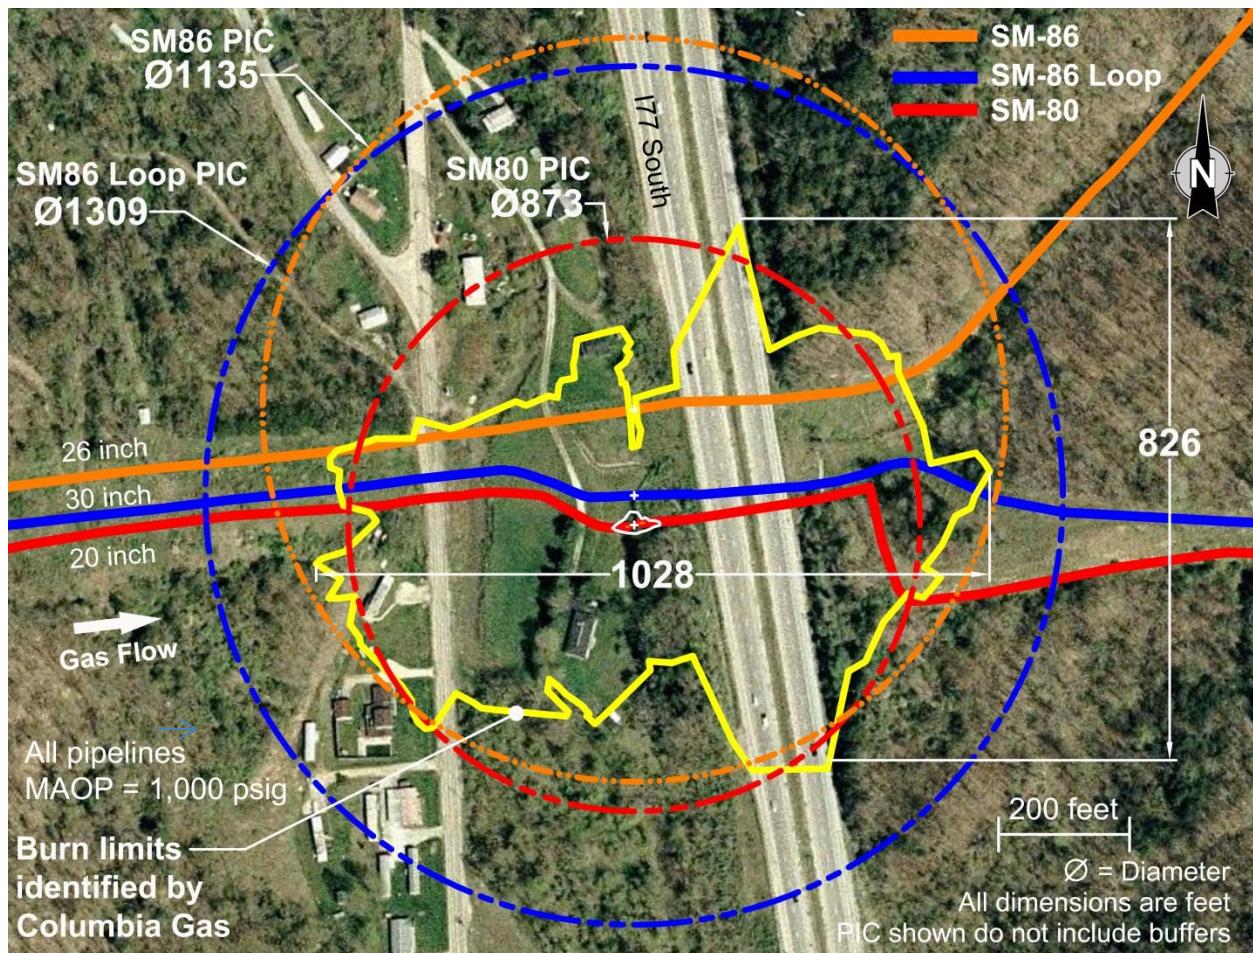
The PIR circles for each pipeline in the SM-80 system at the rupture location are shown in figure 11. Each pipeline is evaluated individually to determine its HCA location. Pipeline

Figure 11. Potential impact radius circles for each pipeline in SM-80 system at rupture location.
